Vulnerability Assessment – Rapid Visual Screening

Major (Dr) C S Sanghvi

L D COLLEGE OF ENGINEERING

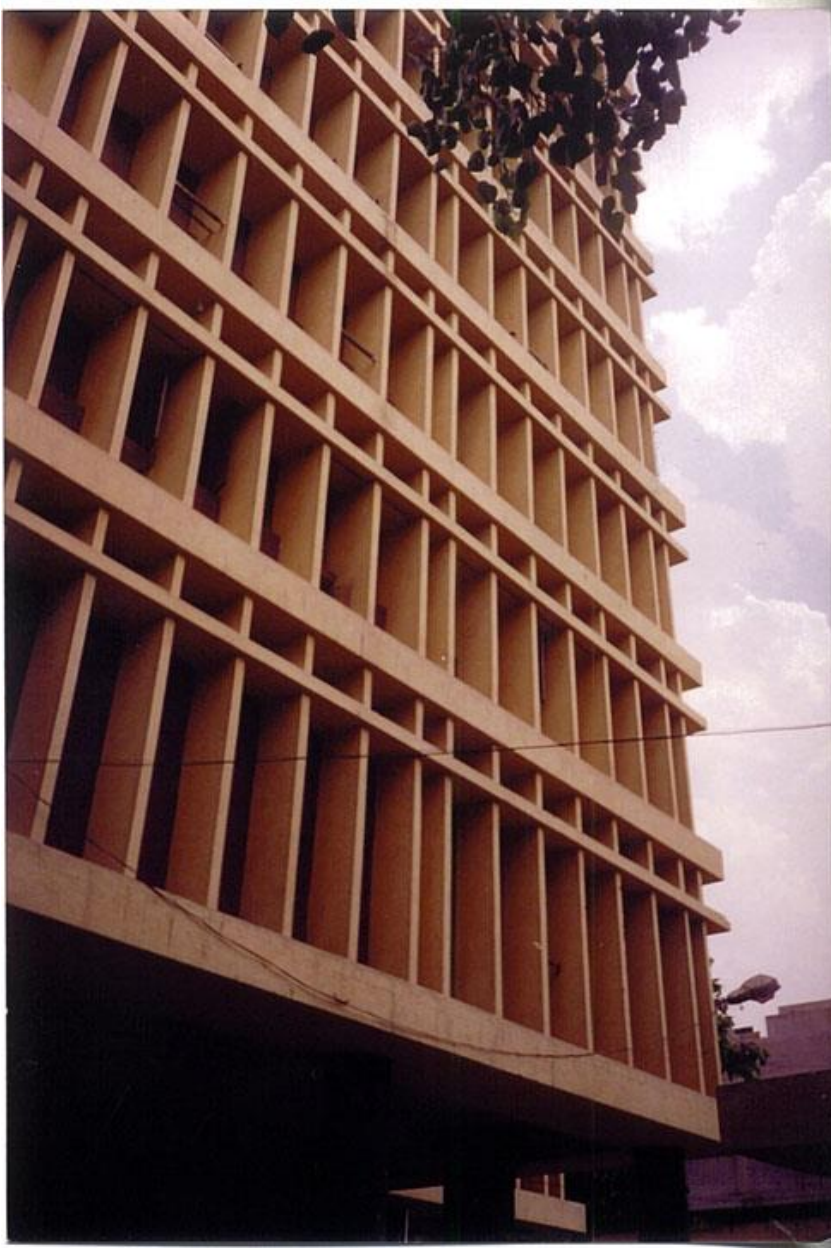
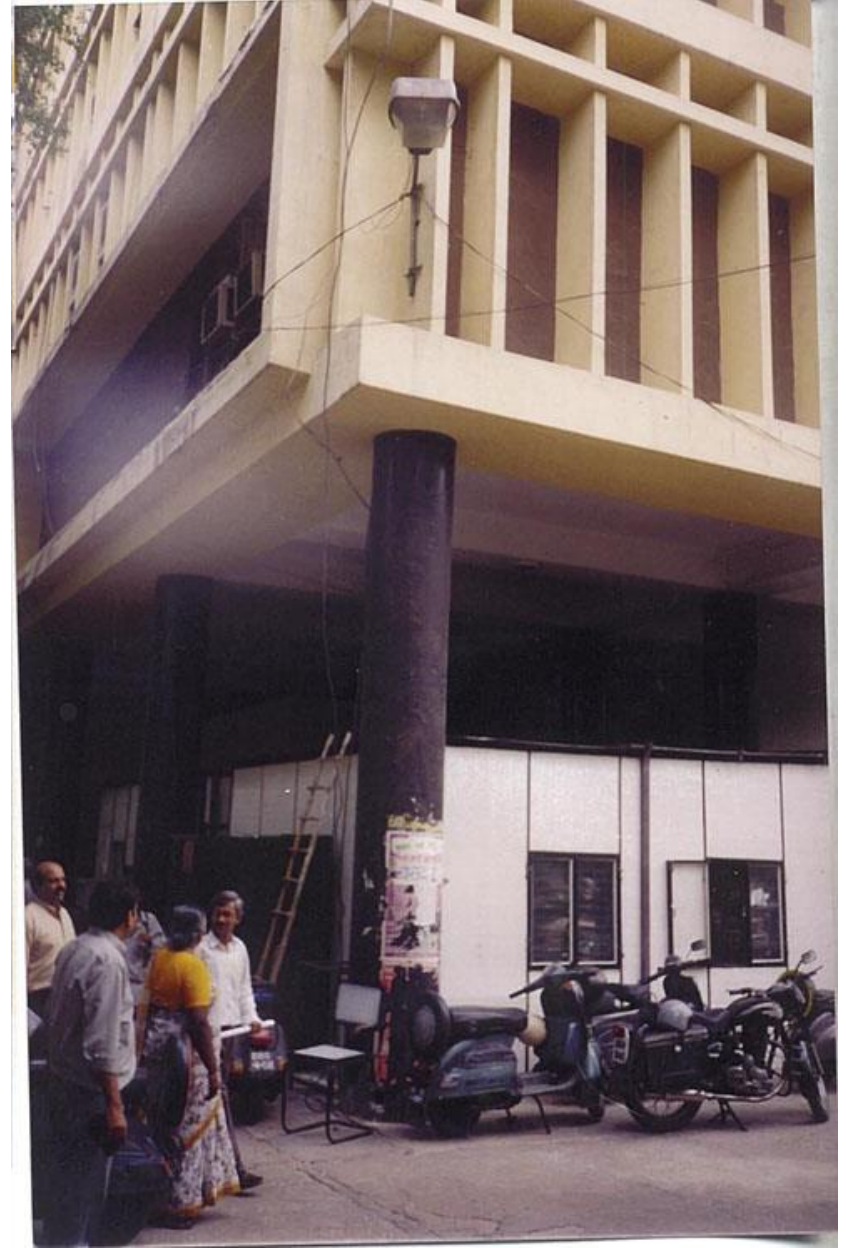
SOFT FIRST STOREY

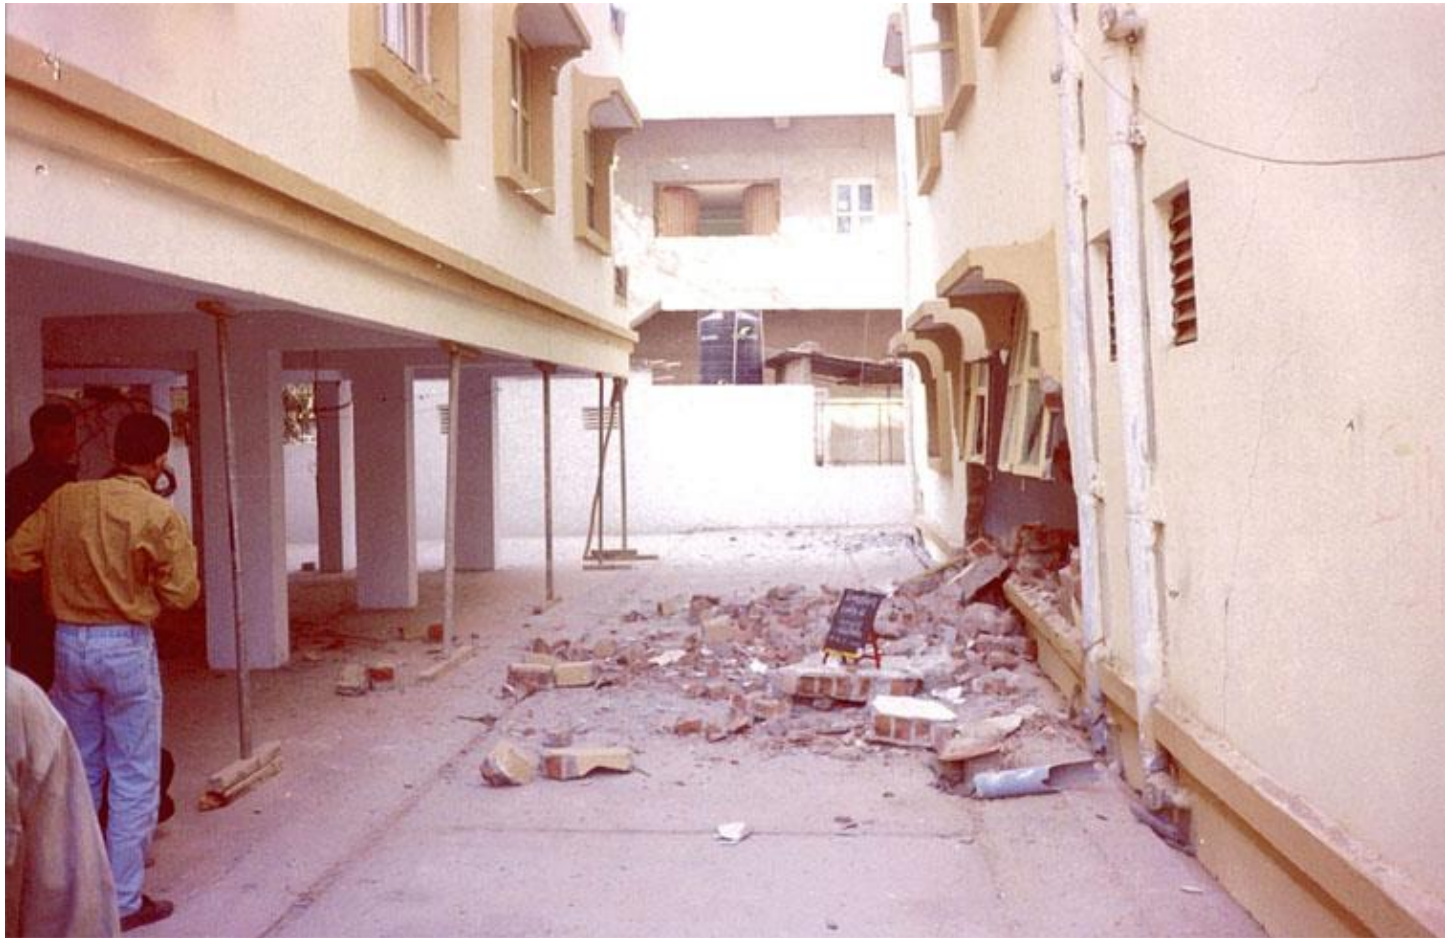
DAMAGE TO SOFT FIRST STOREY BUILDING DURING EARTHQUAKE

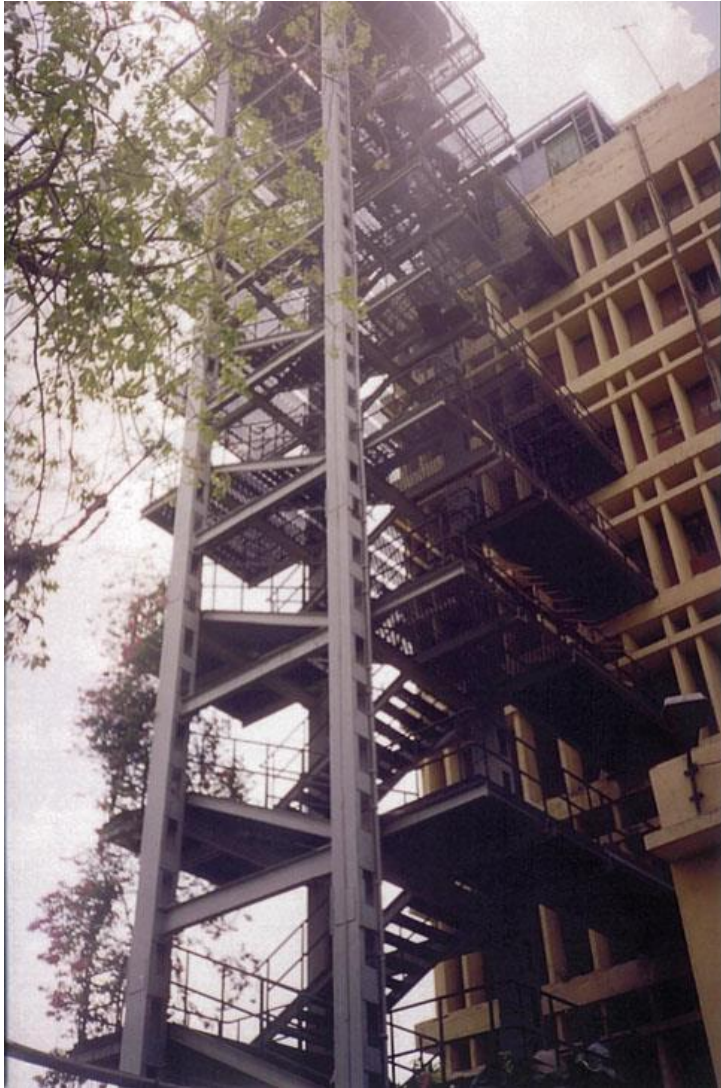
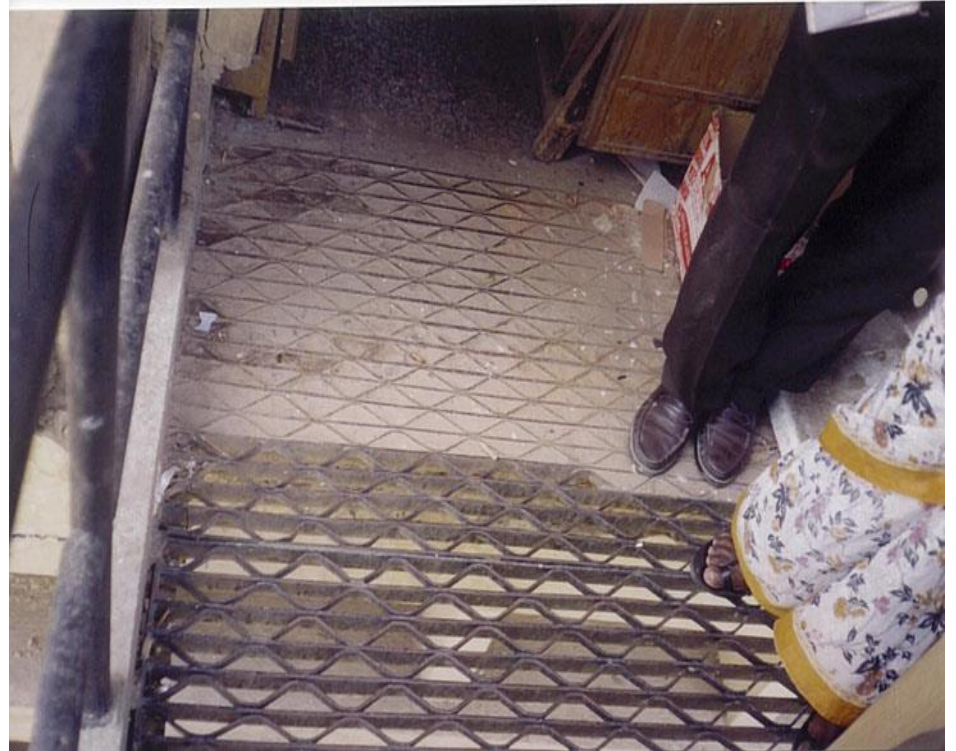
DISSIMILAR ADJACENT BUILDING

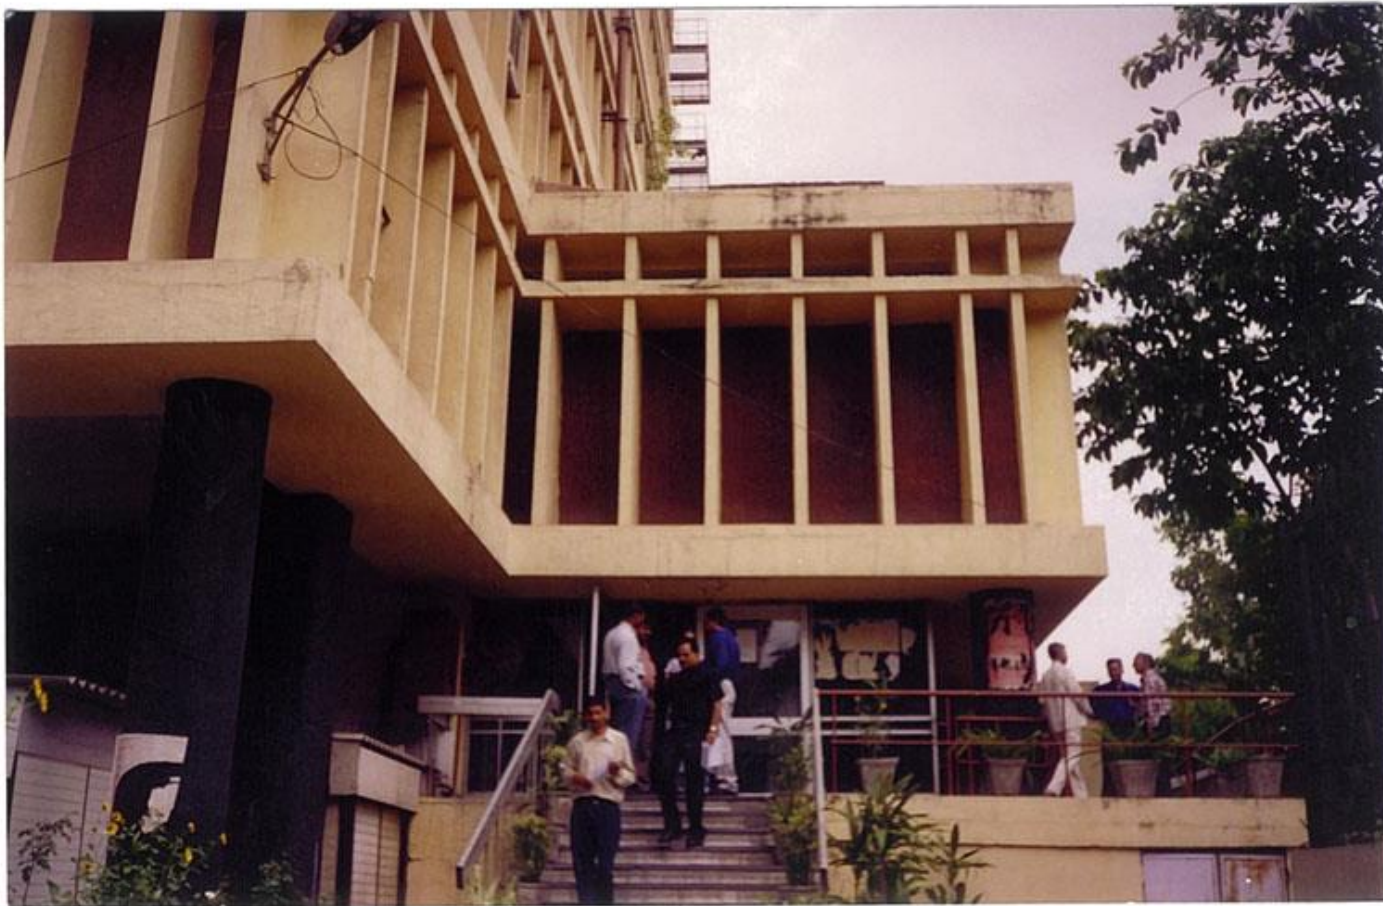
STIFFNESS AND PLAN IRREGULARITY

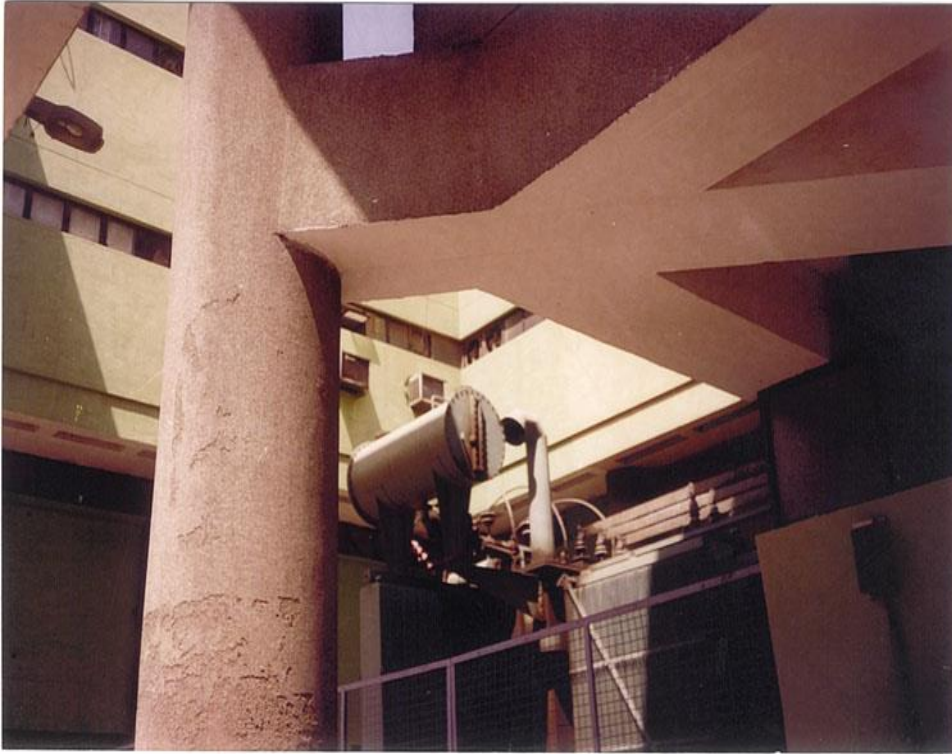
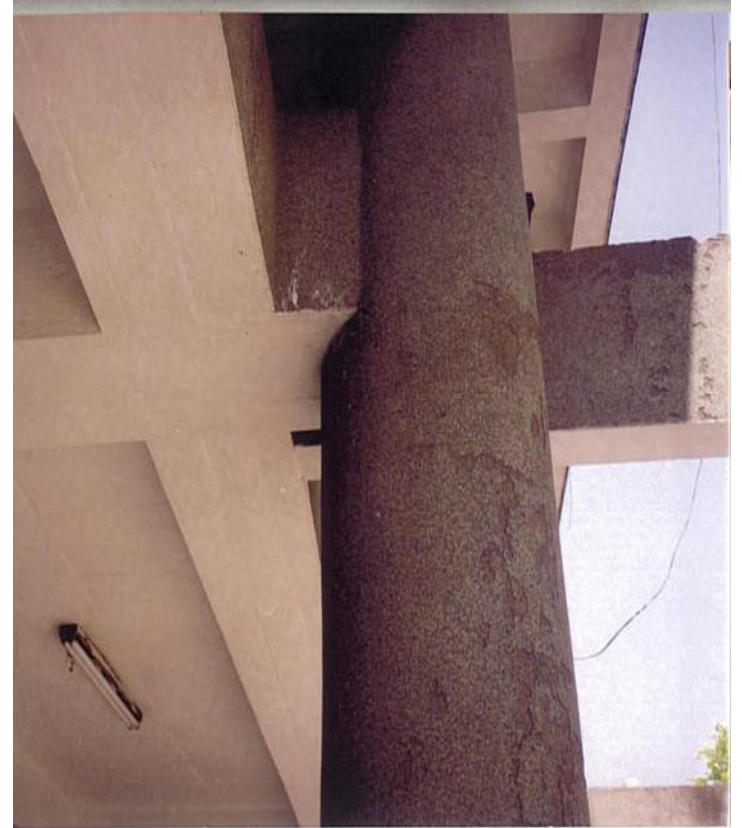
BEAM COLUMN OFFSET

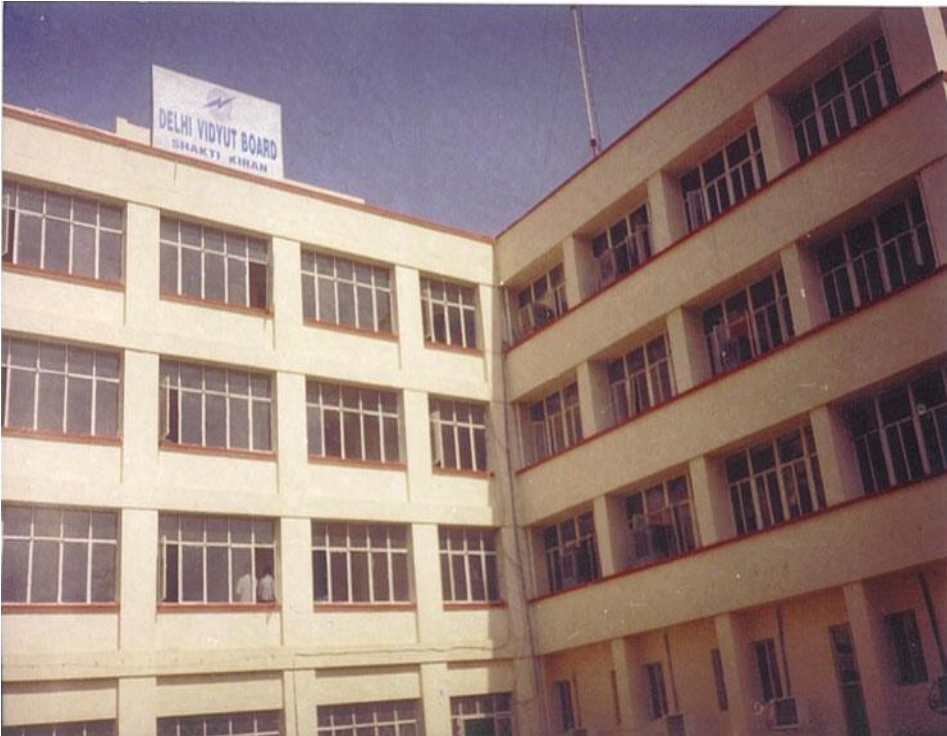
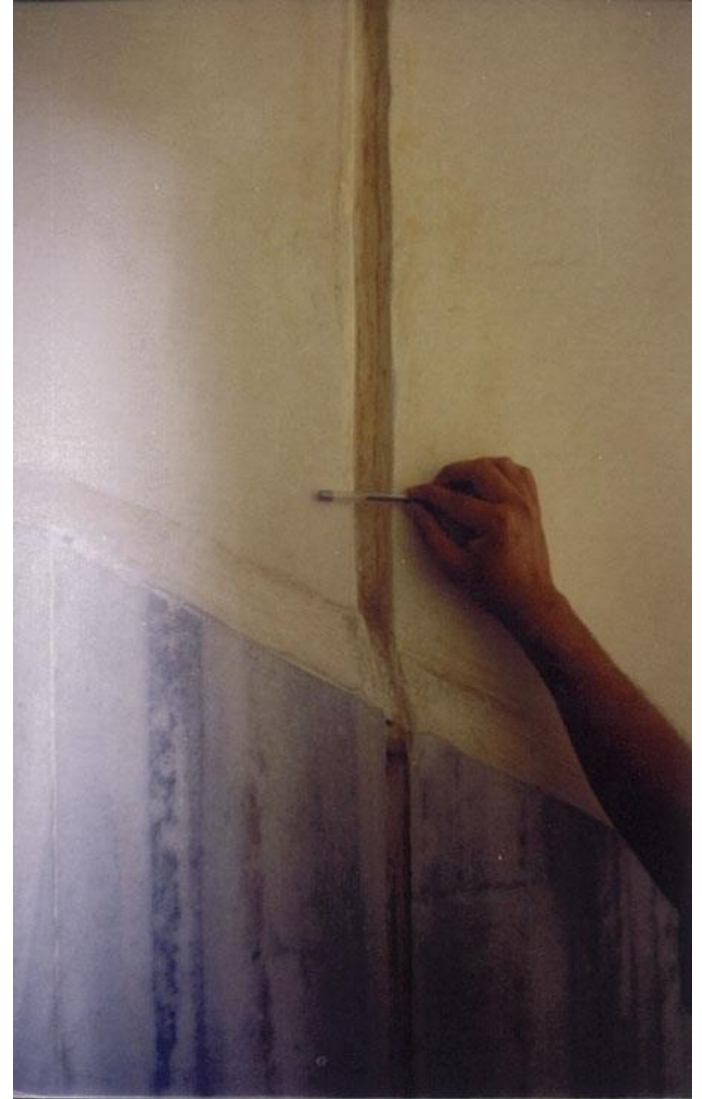
NON-FUNCTIONAL SEPARATION JOINT

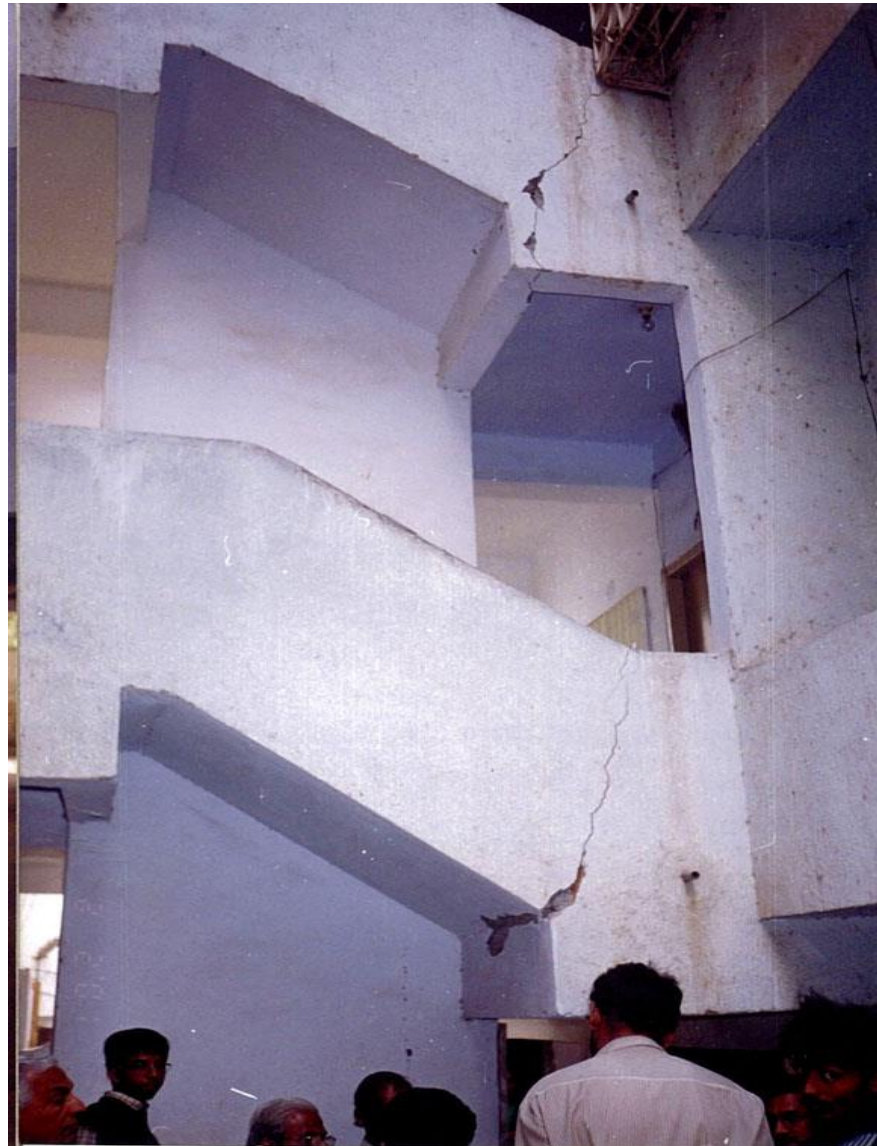
MONOLITHIC STAIRCASE

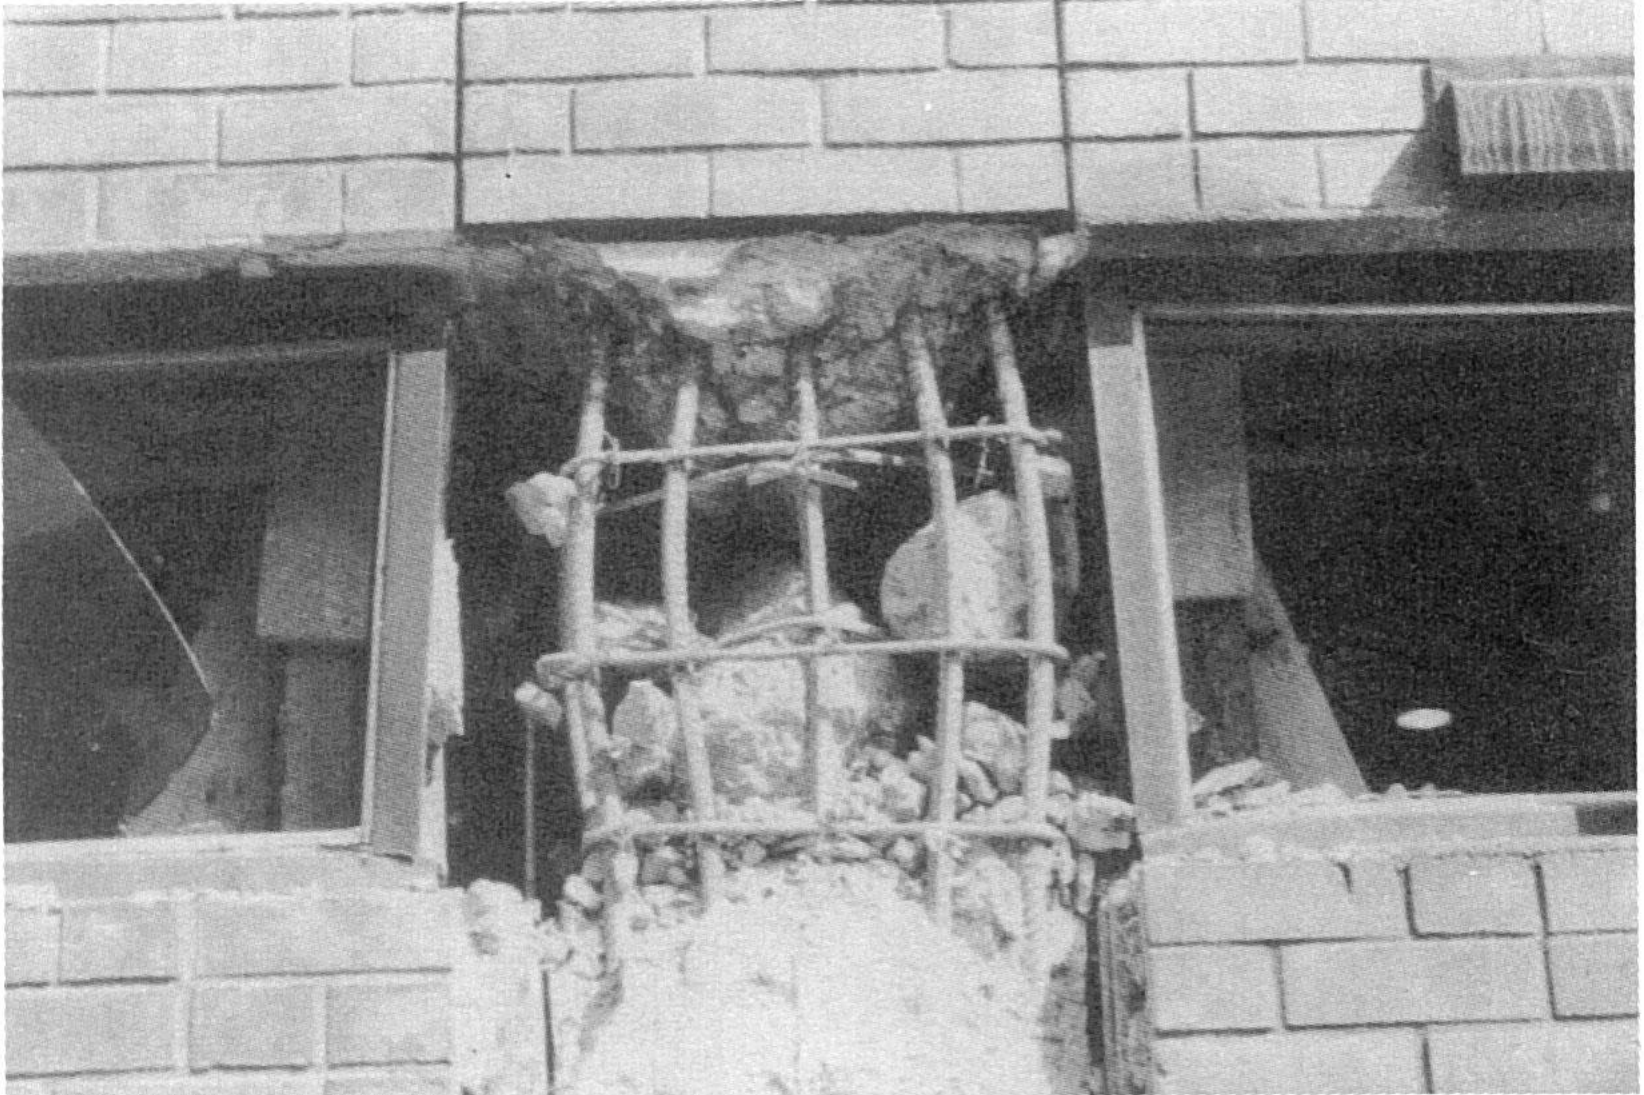
SHORT COLUMN EFFECT

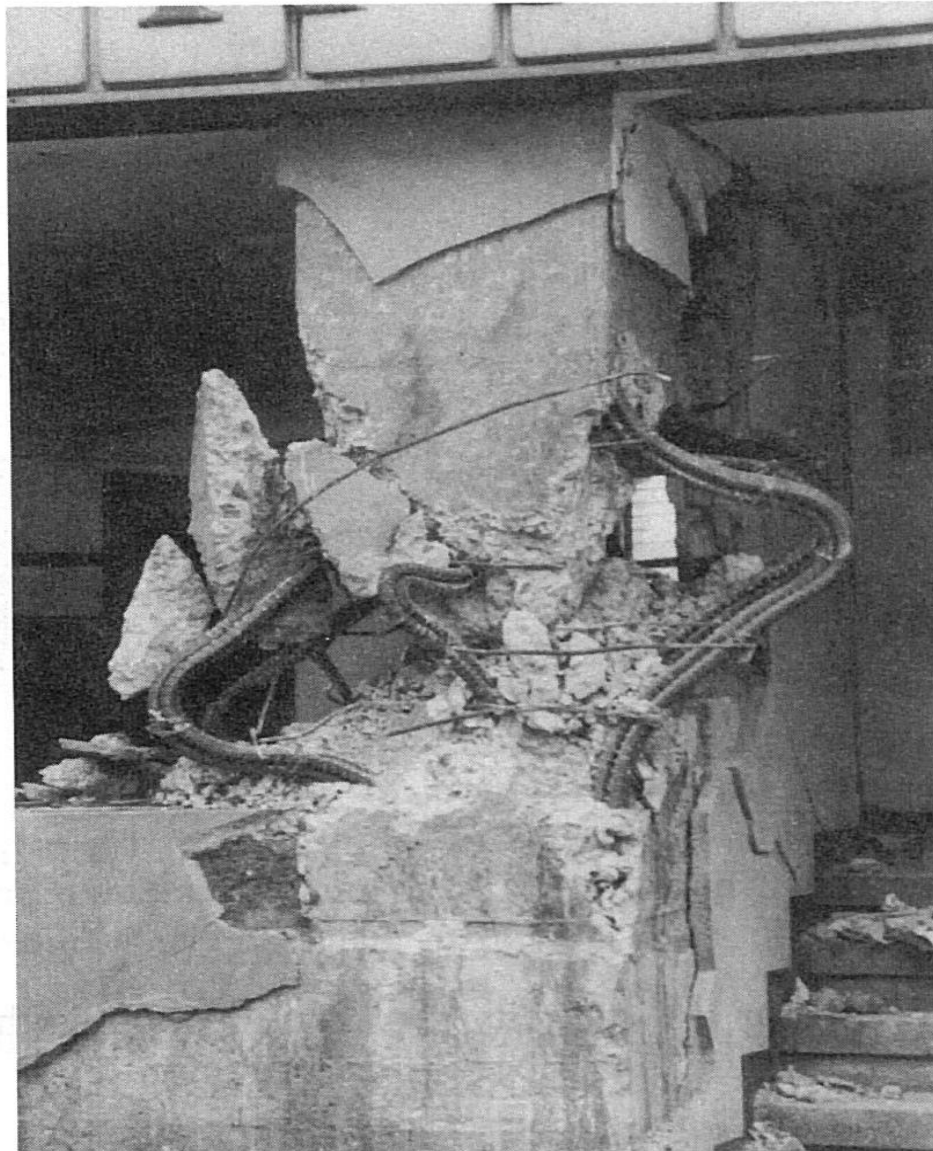
LACK OF CONFINING

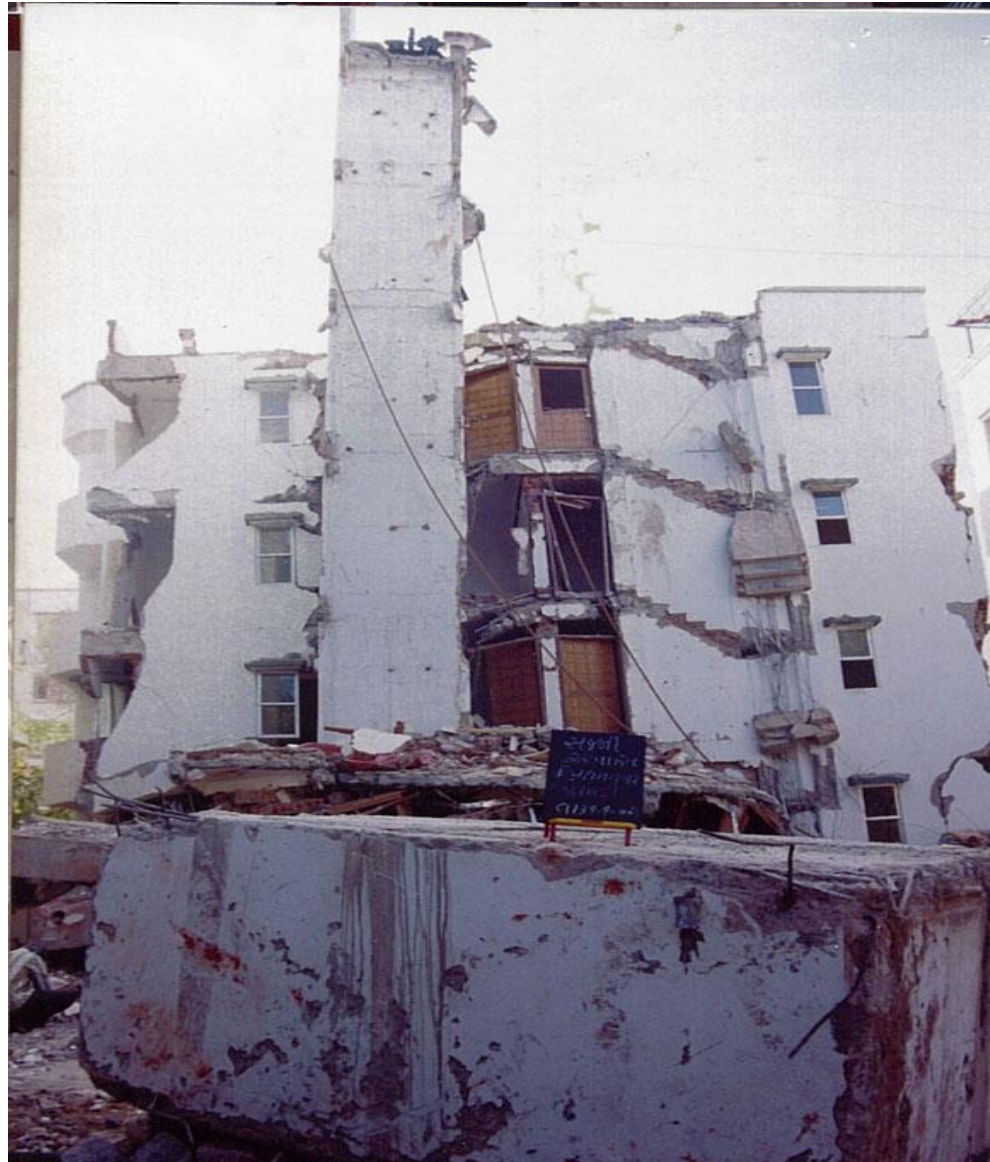
LACK OF ANCHORAGE

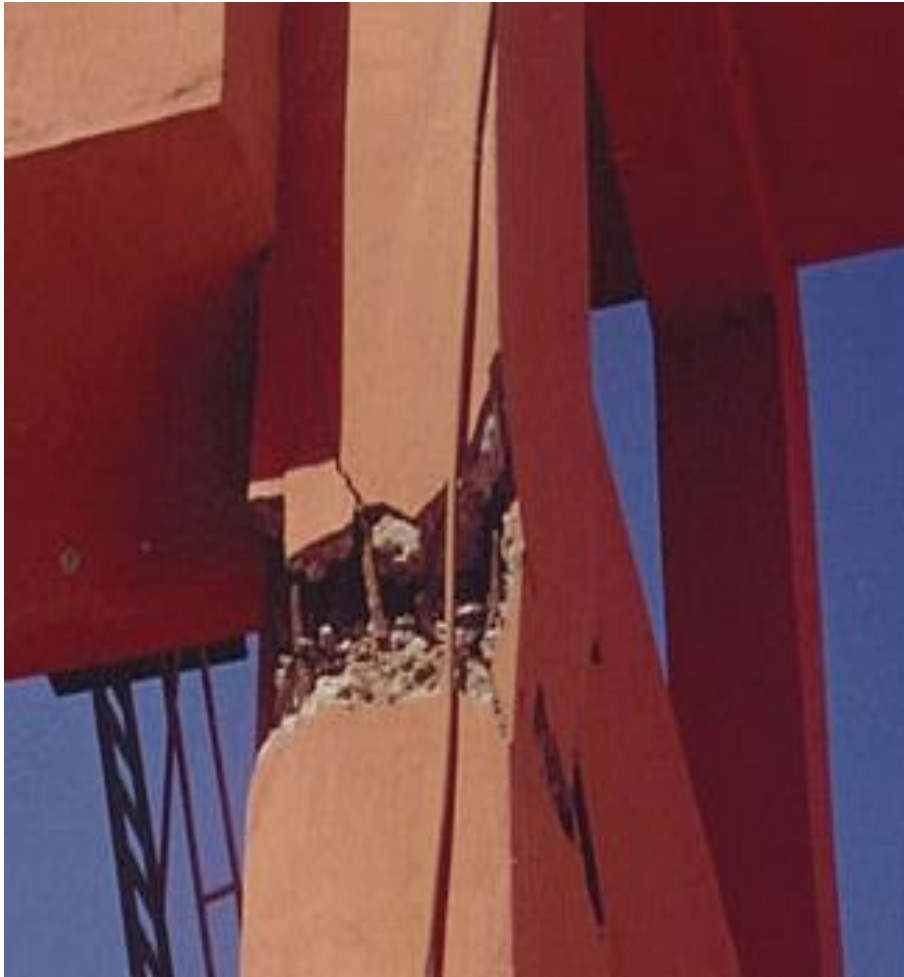
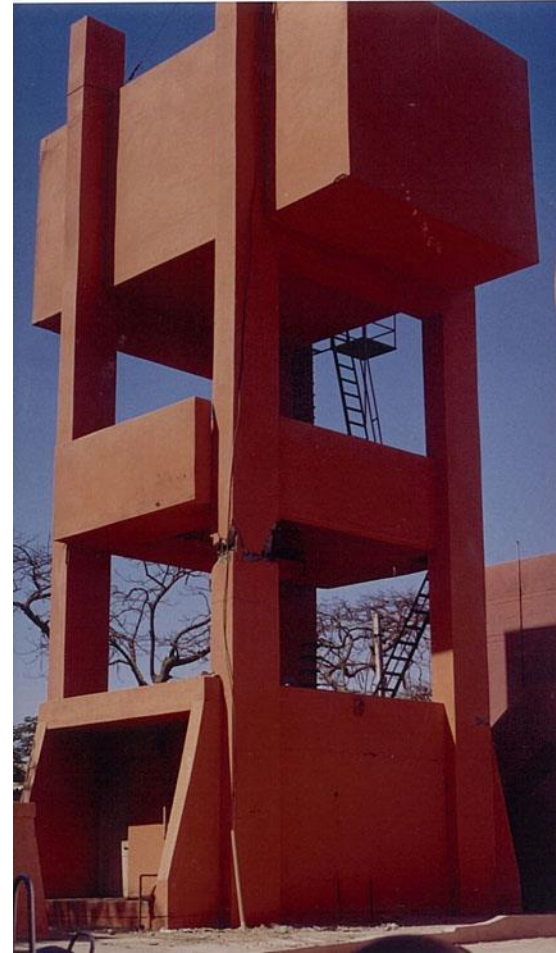
IMPROPER SPLICING
