# Structural Retrofit and Structural Risk Mitigation

Manish Kumar

*Training Workshop on Structural & Non-structural Risk Assessment of School Buildings*

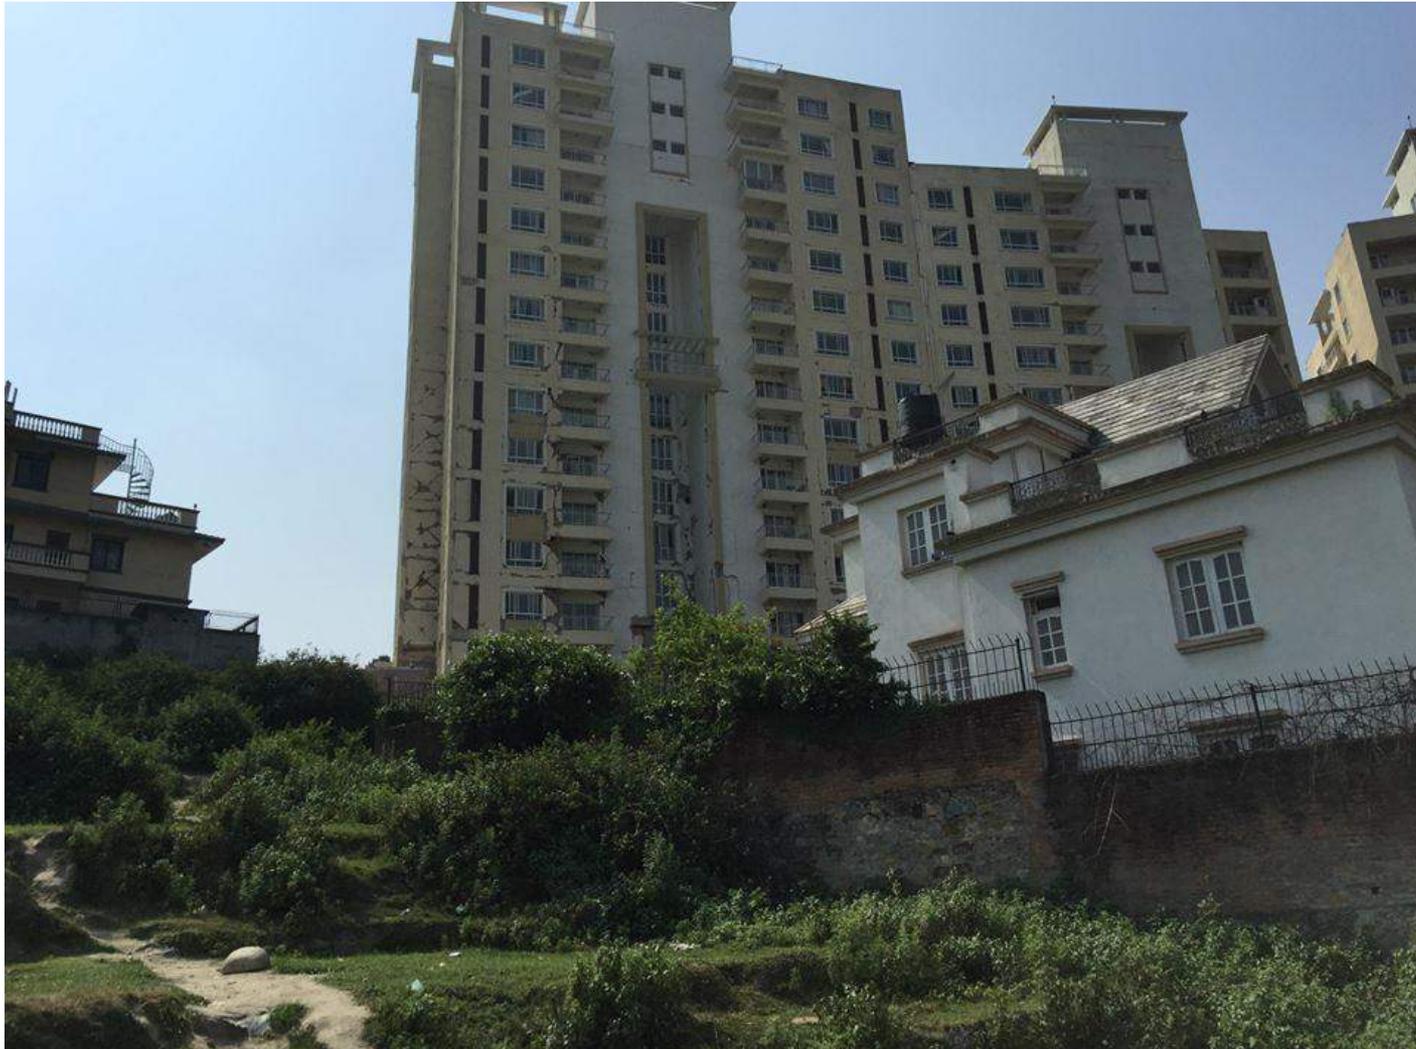
2015 Nepal earthquake: photo by UB team

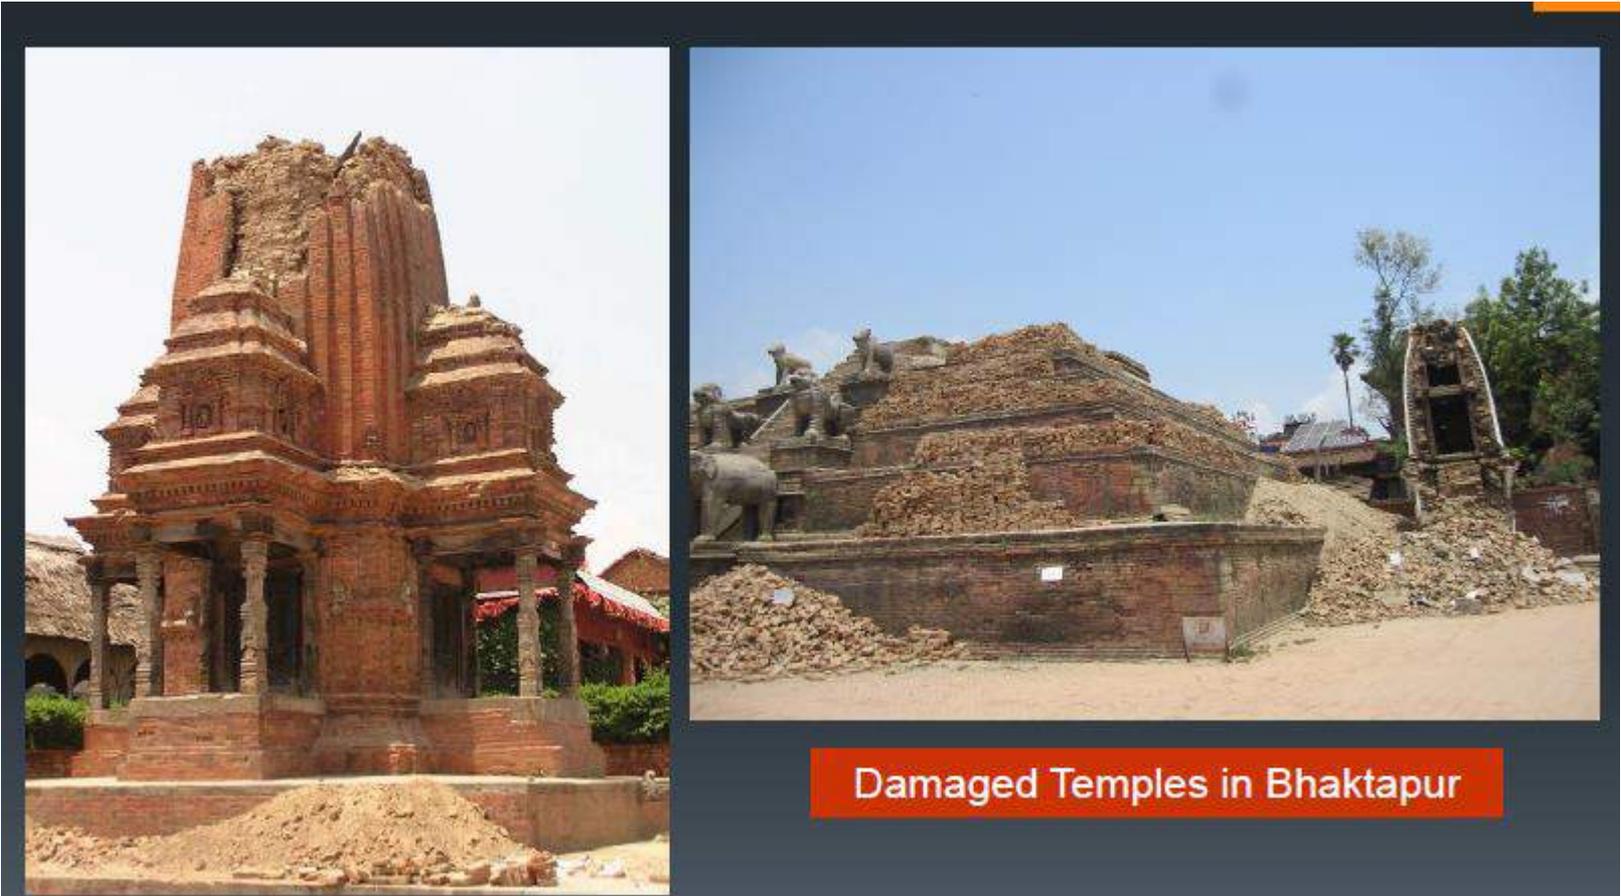
# Structural damage

2015 Nepal earthquake: photo by IITK team

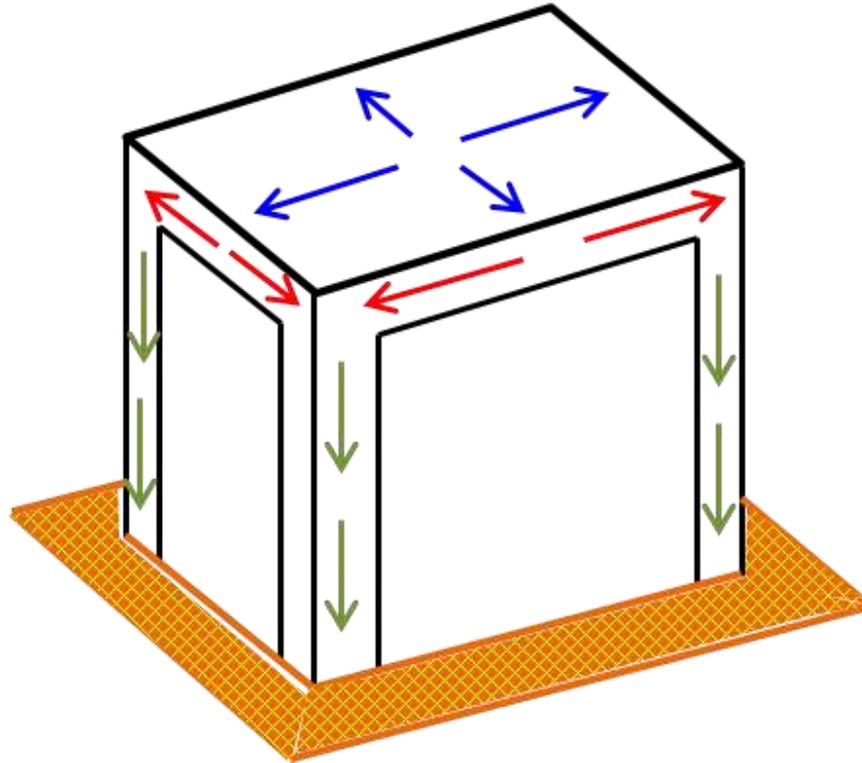
- Load transfer path
  - slab >>> beams >>> columns

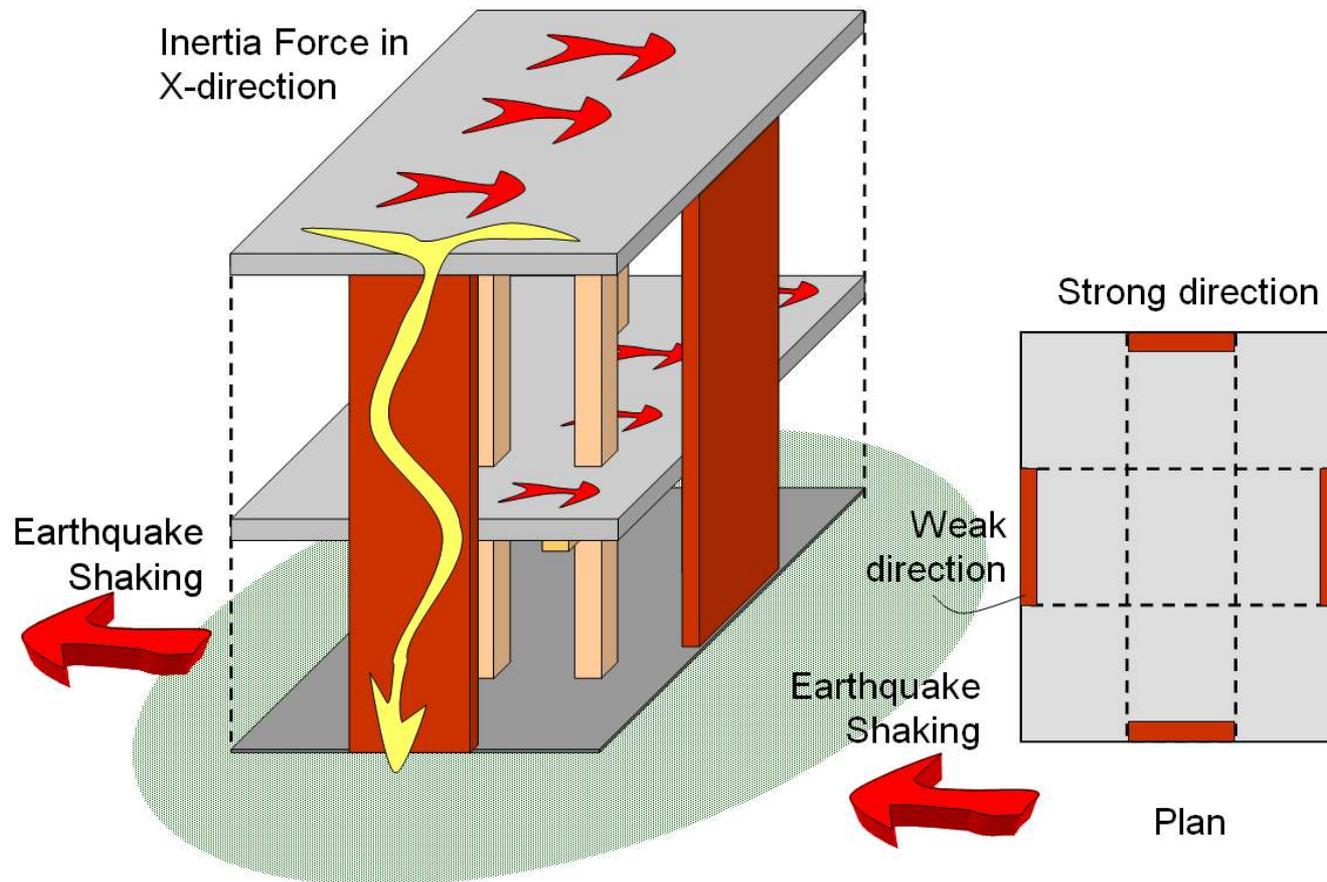
# EQ load path: direction of loading

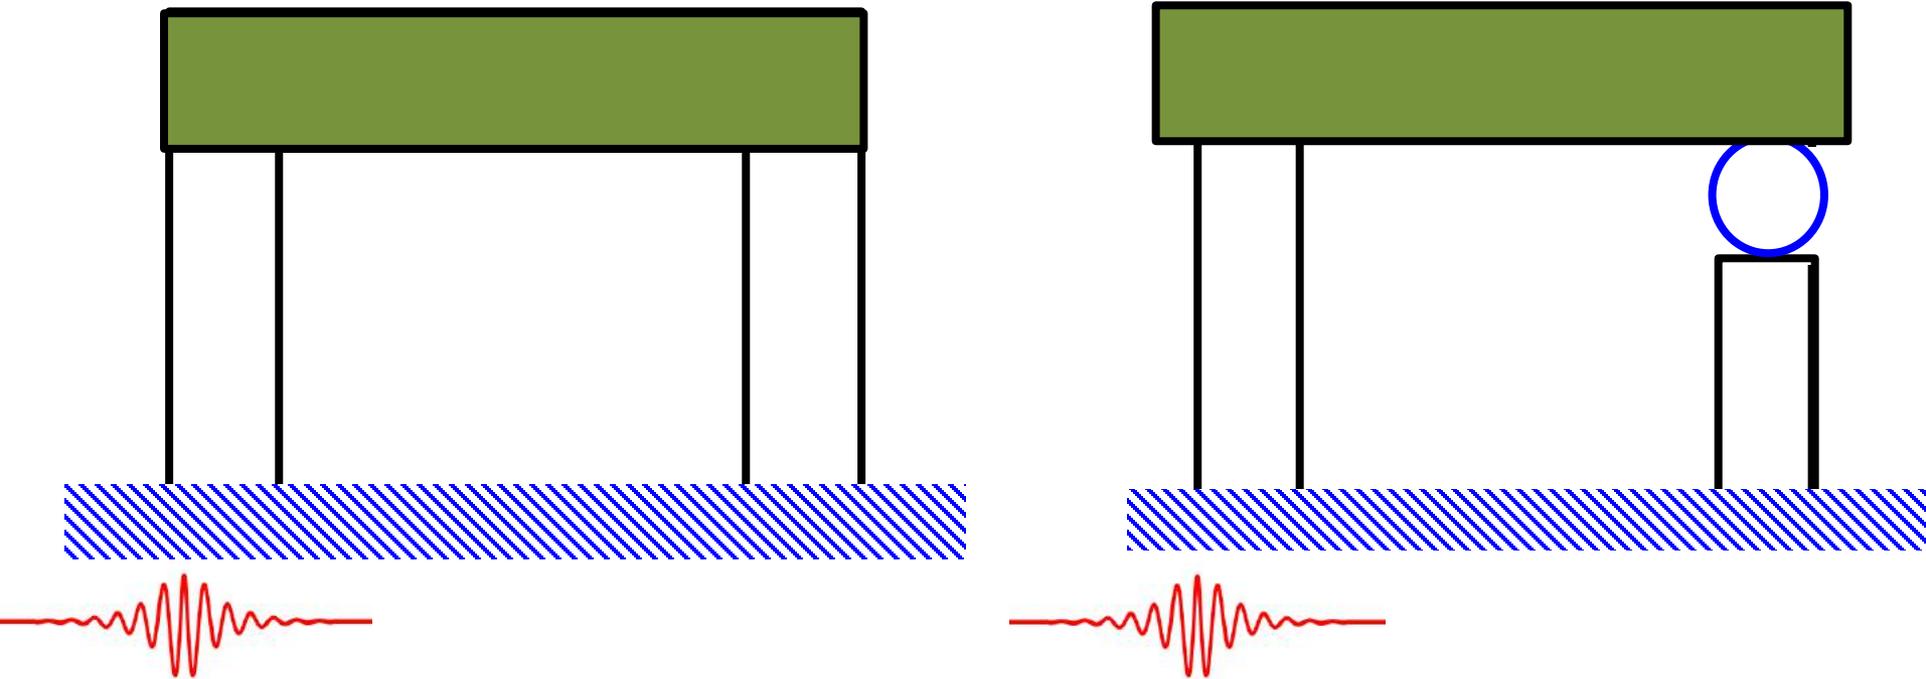
# EQ load path: support condition

- Member forces affected by support conditions

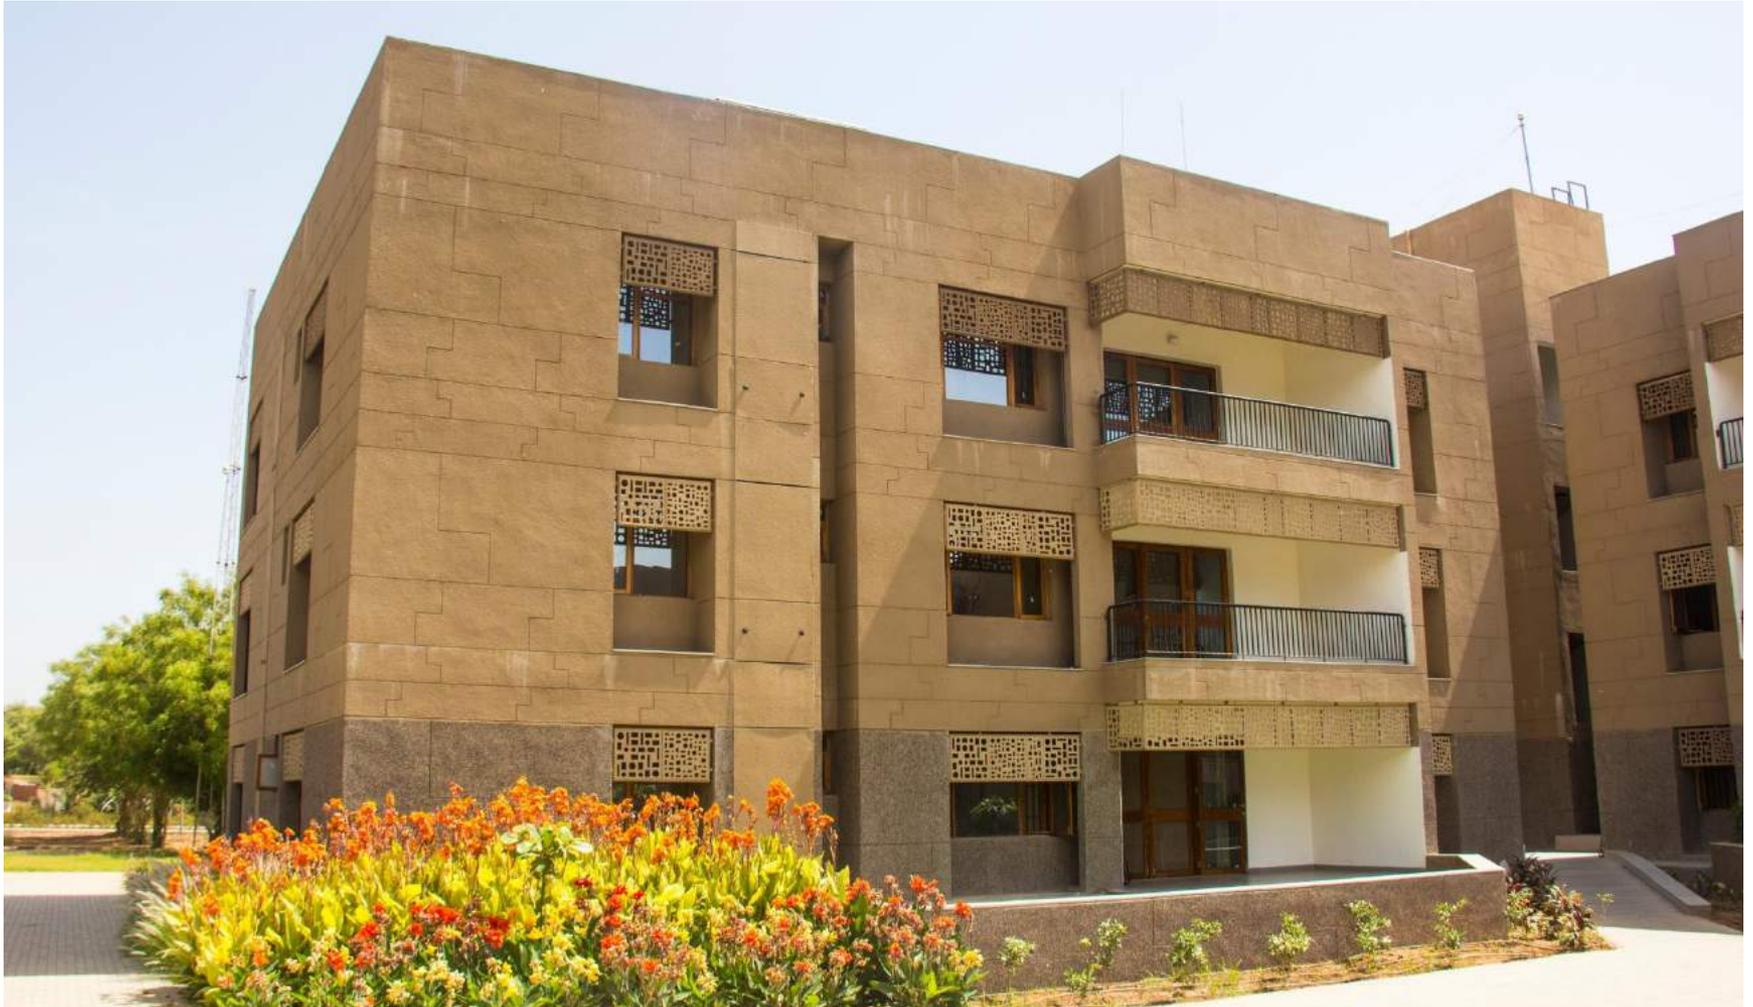
# Faculty apartments: confined masonry

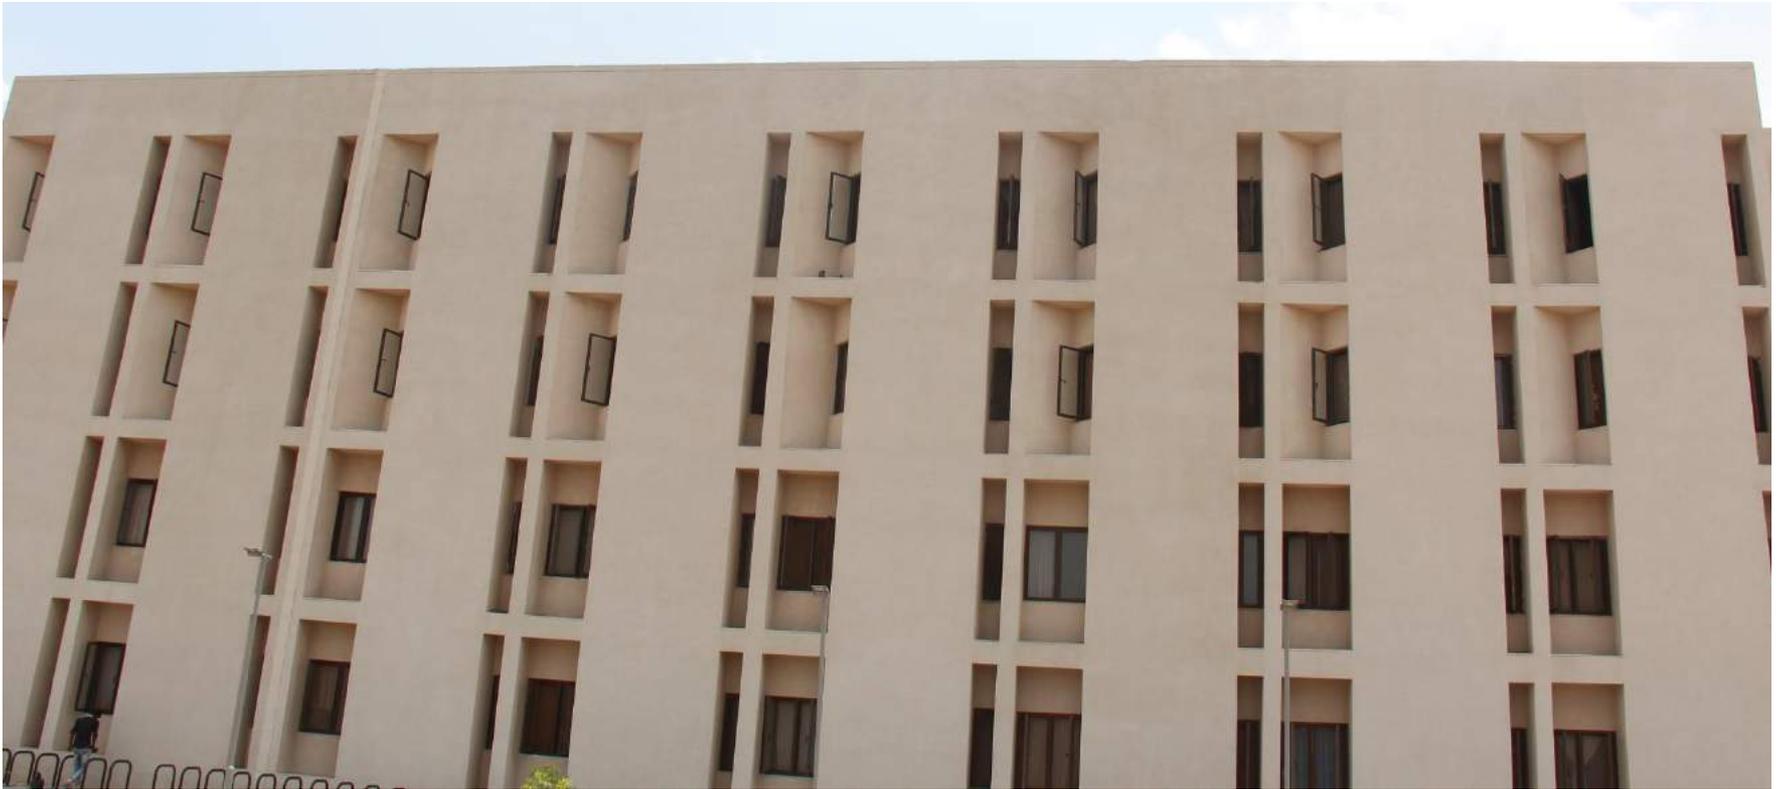
# Student hostel: confined masonry

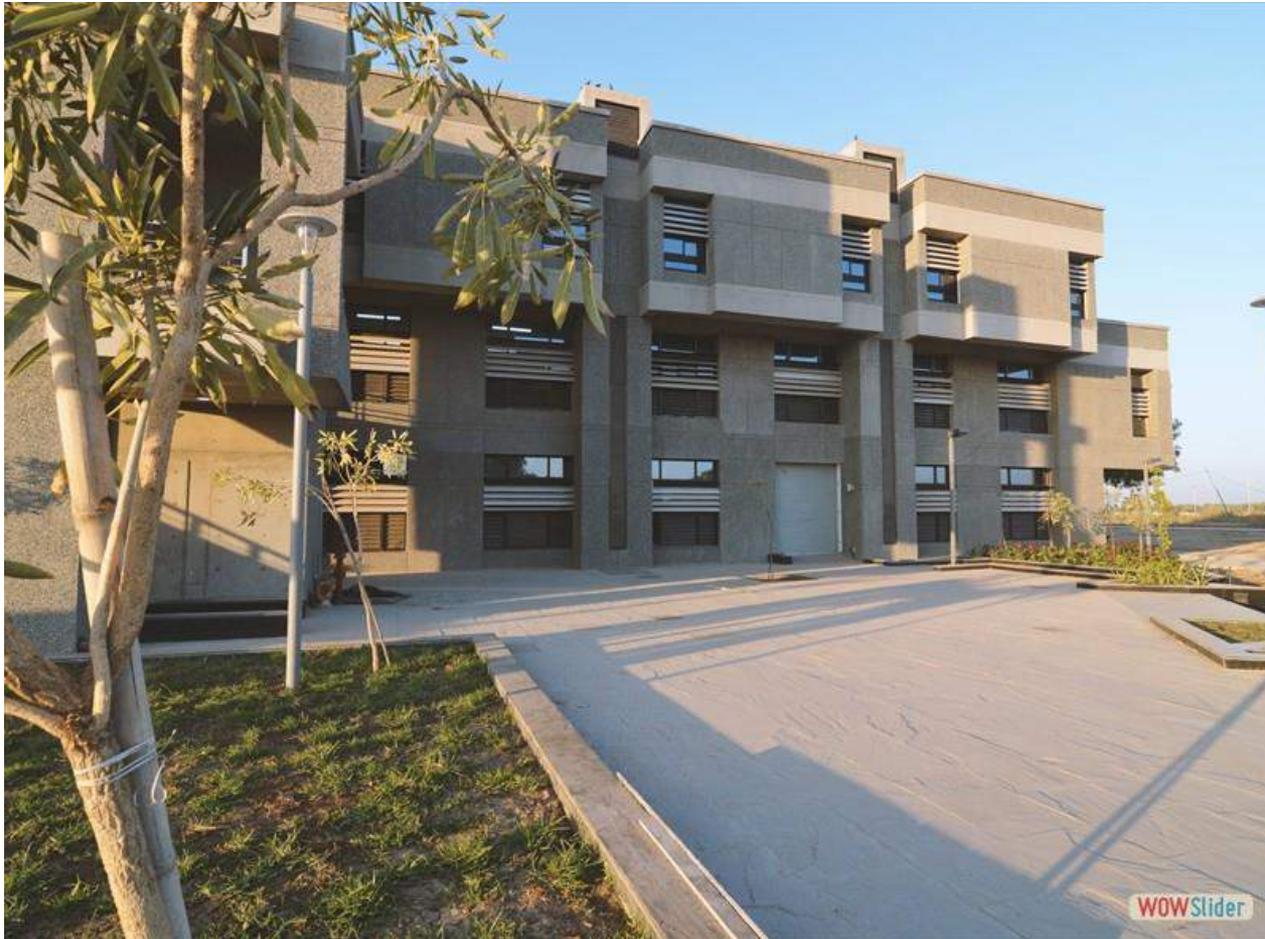
# Academic area: infilled RC frame

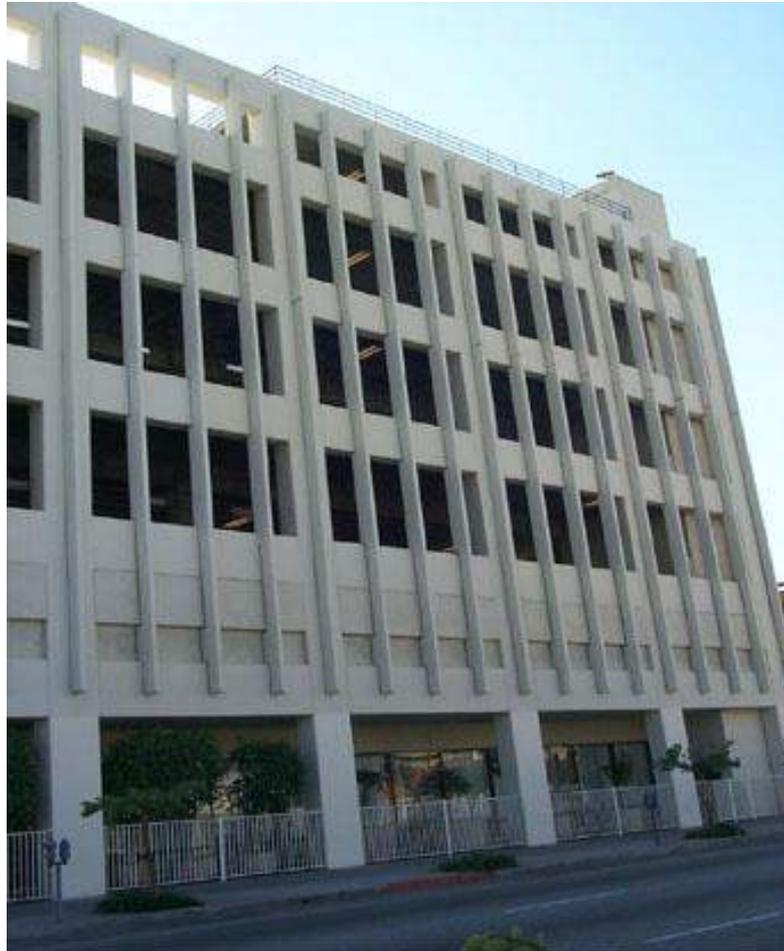
# Concrete moment-resisting frame

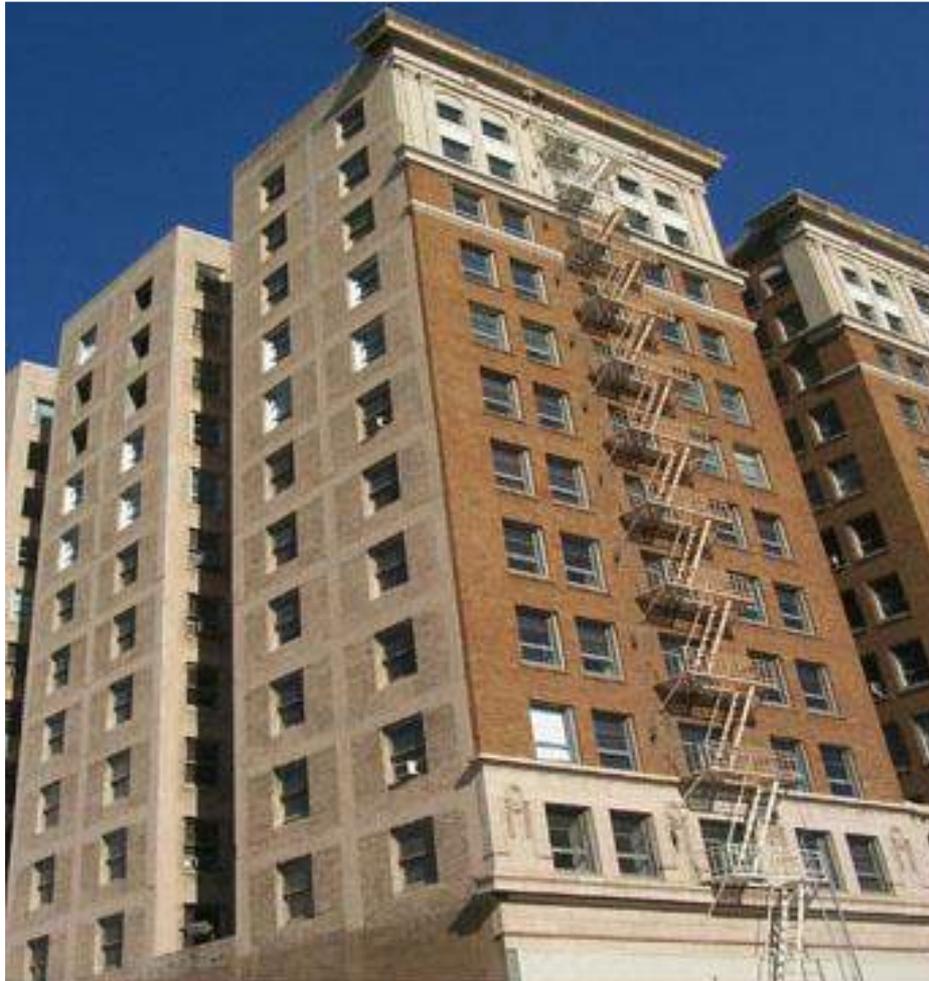
# Concrete frame with masonry

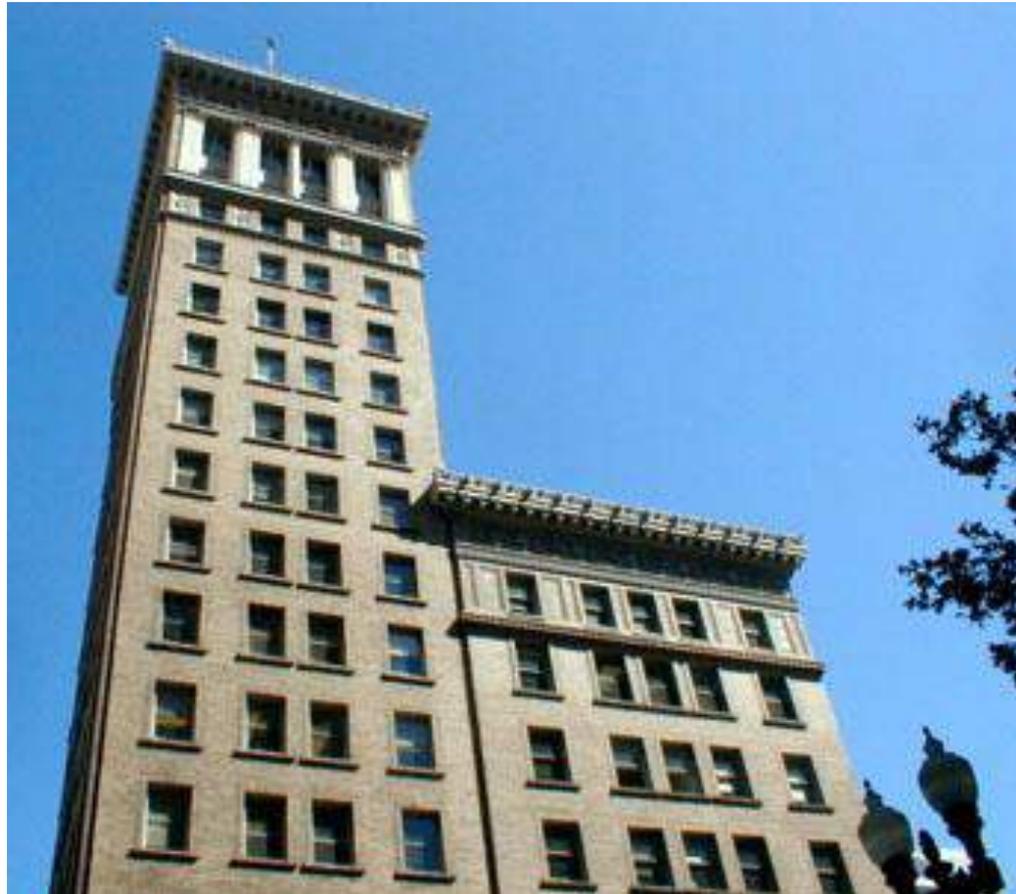
# Steel frame with masonry

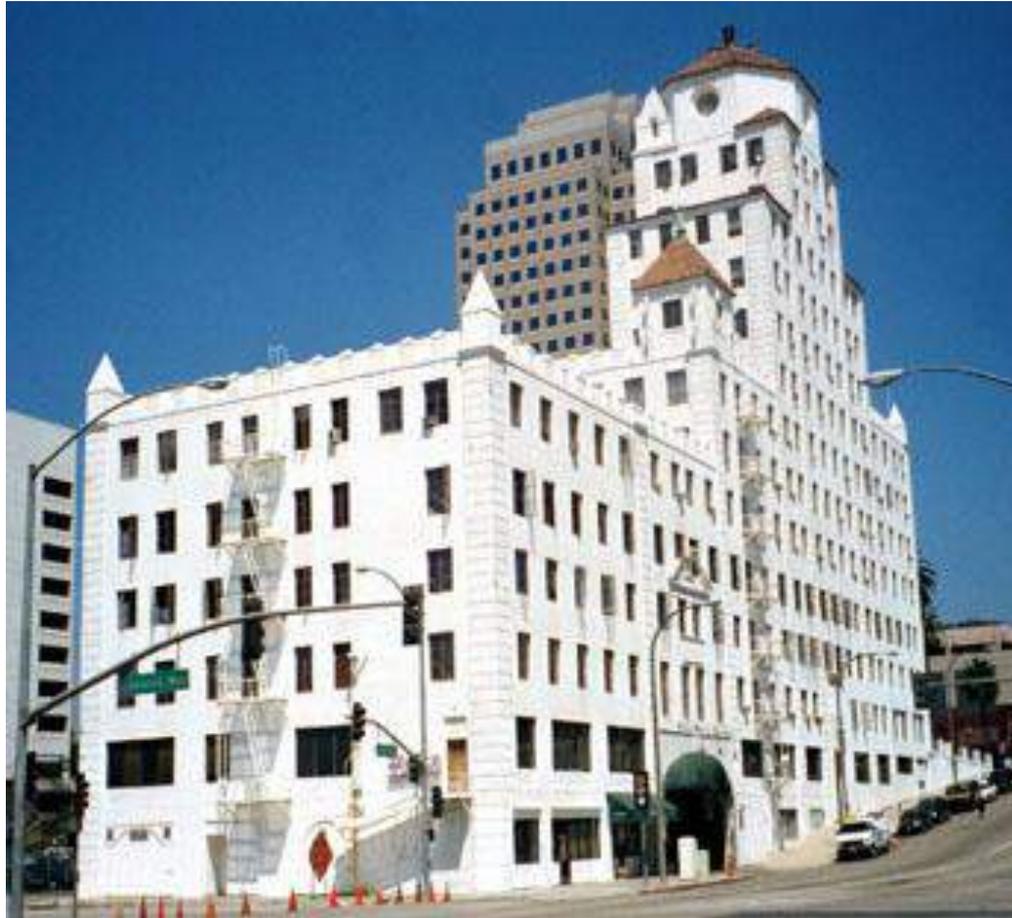
# Steel frame with concrete wall

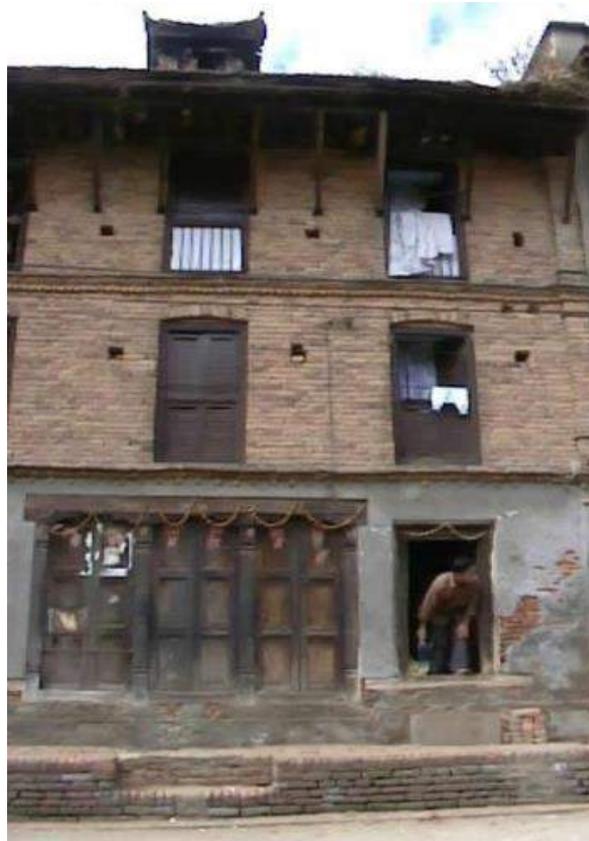
# Nawari house

- Kathmandu, Nepal

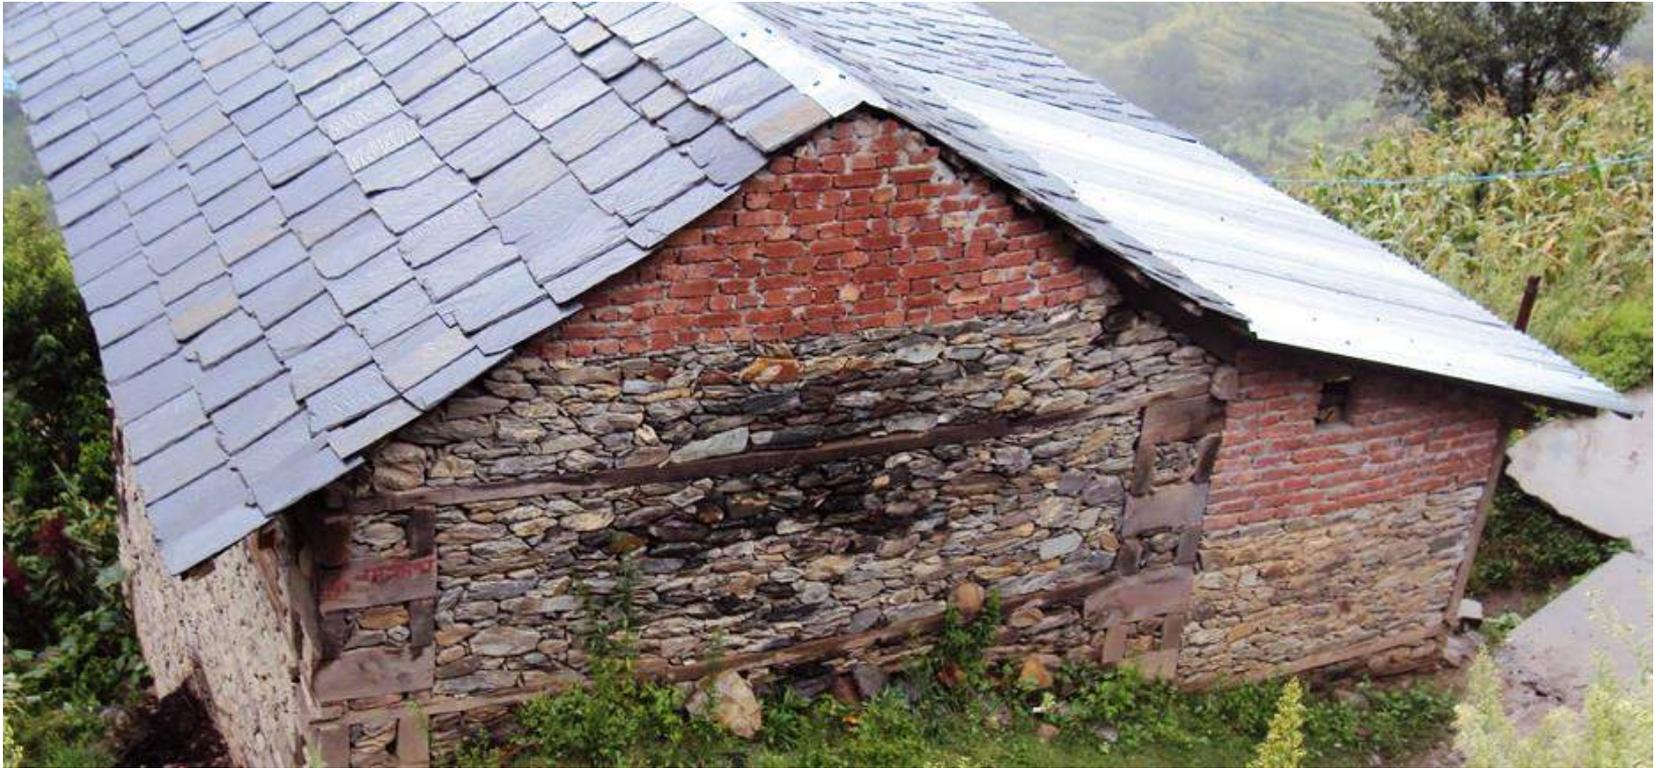
# Thathara house

- Himachal Pradesh, India

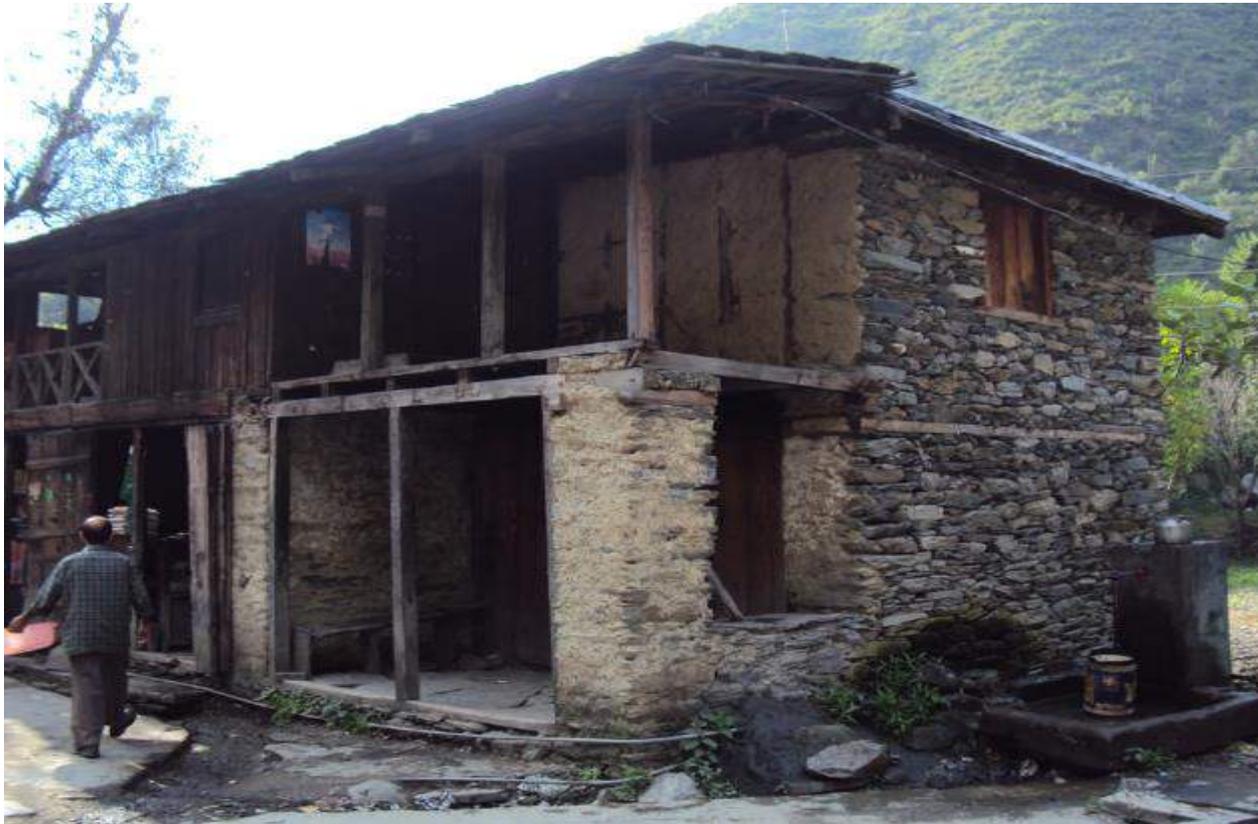
# Dry stone construction

- Himachal Pradesh, India

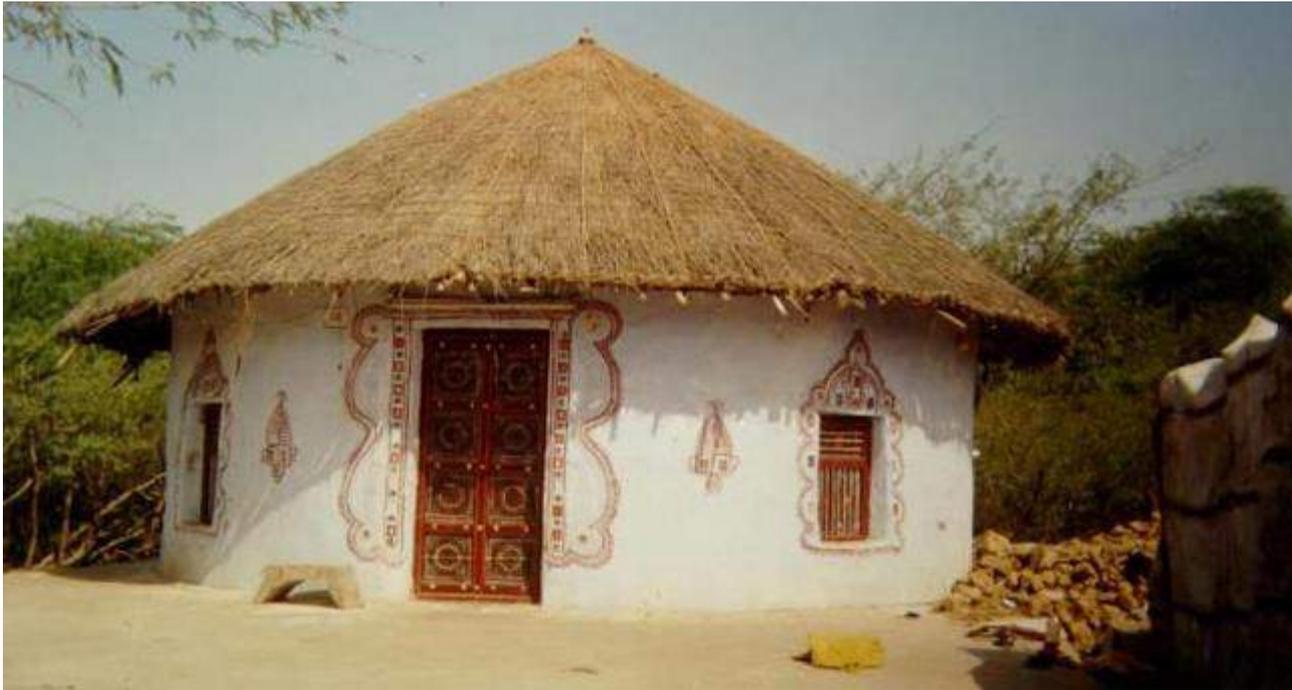
# Bhonga house

- Kutch, India

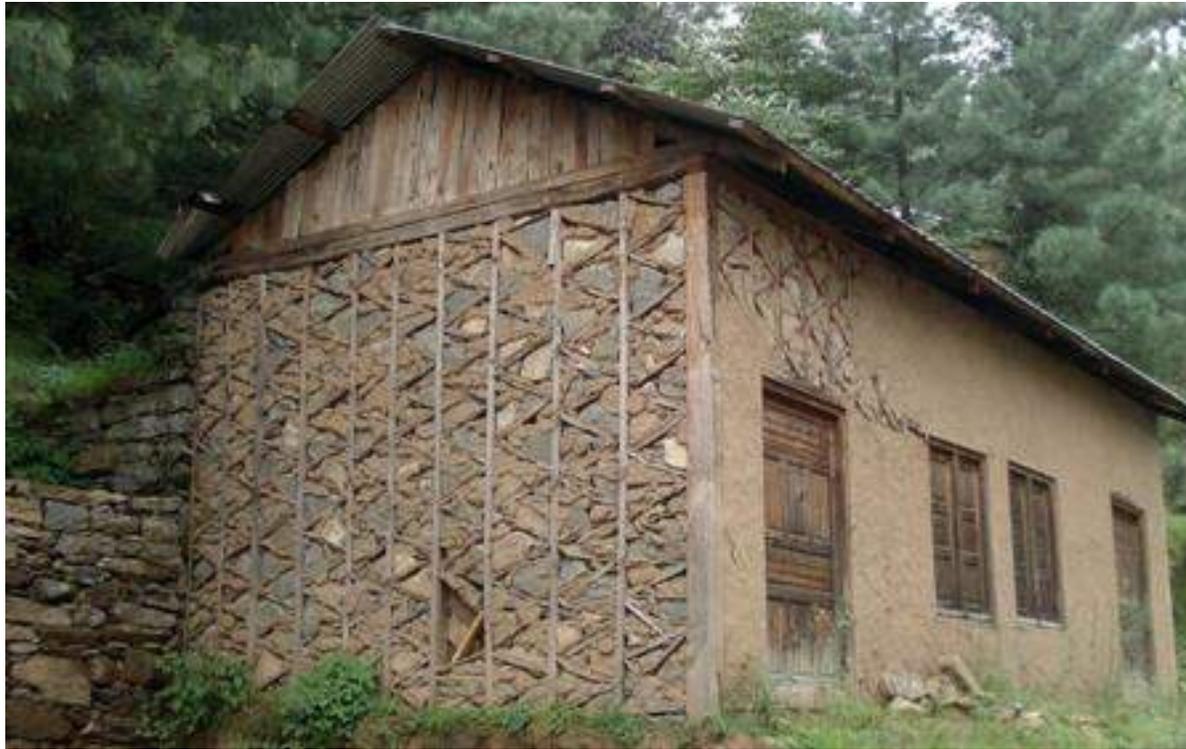
# Dhajji dewari house

- Kashmir, India

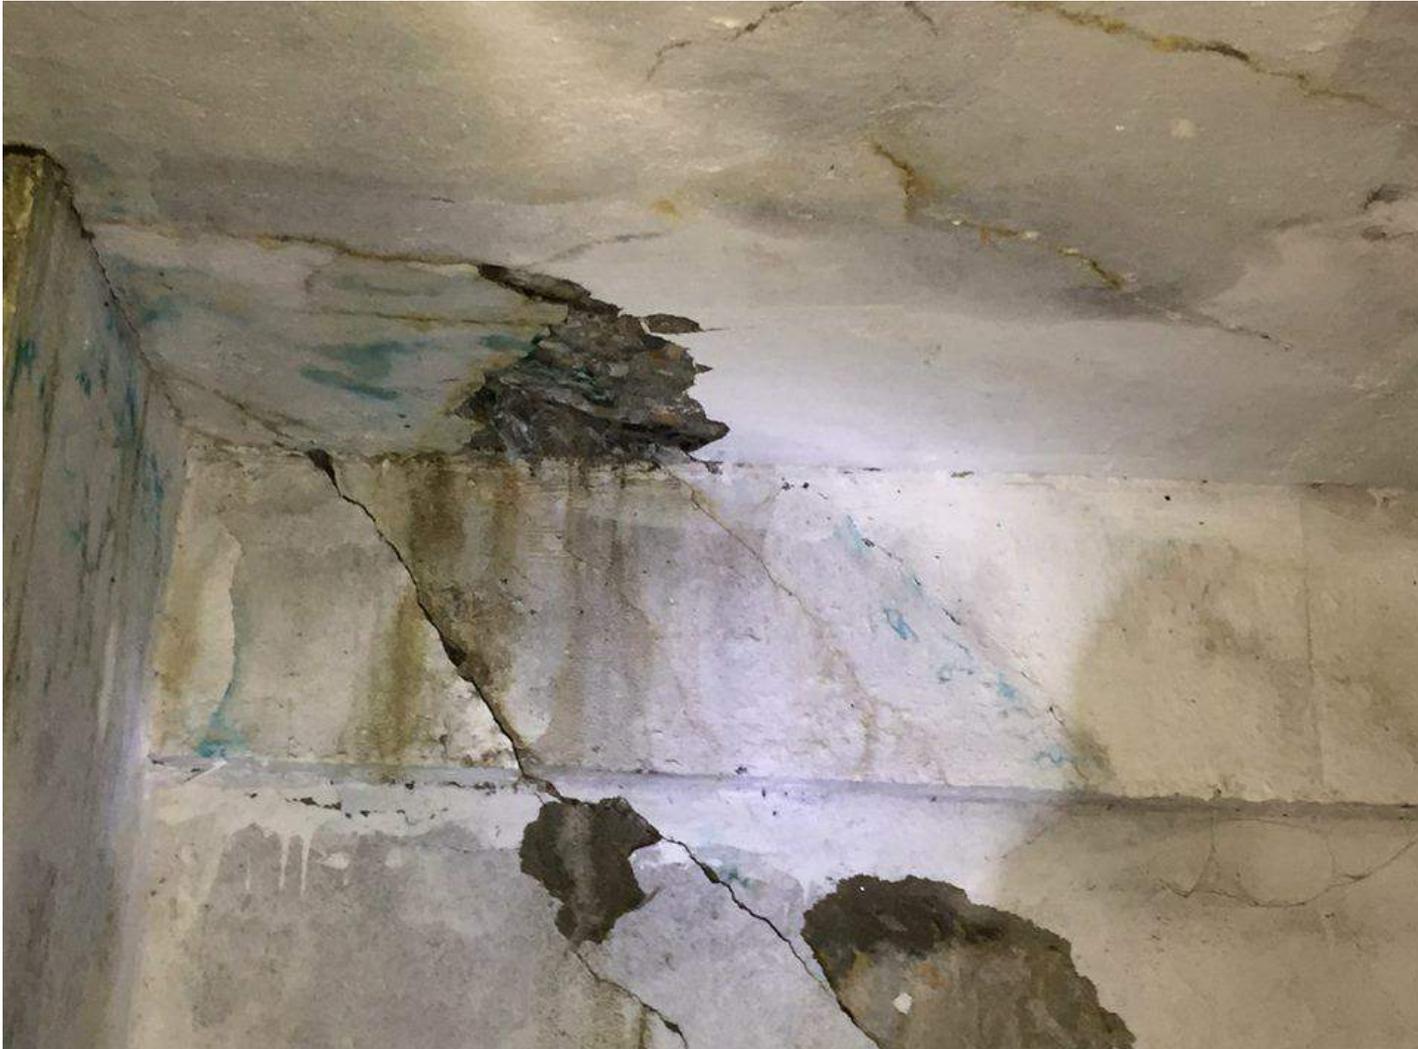
# Maintenance

- Effect of poor maintenance
  - Leakage/seepage affects the strength of building materials
    - Corrosion leads to further cracks
  - Poor maintenance affects the building performance score **twice** as much as **soft story**, **re-entrant corners** or **short columns**
- Owners may be encouraged to maintain the building better

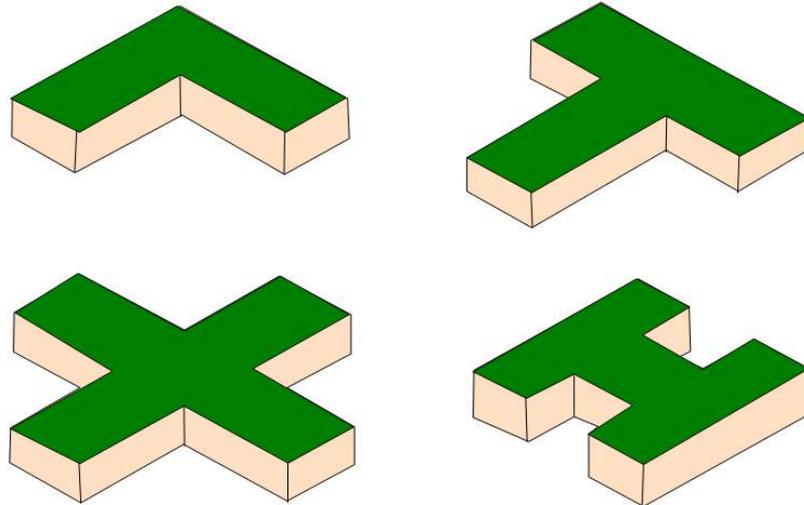
- Issues
  - Unsymmetrical plan may lead to torsion
  - Stress concentration at the re-entrant corners

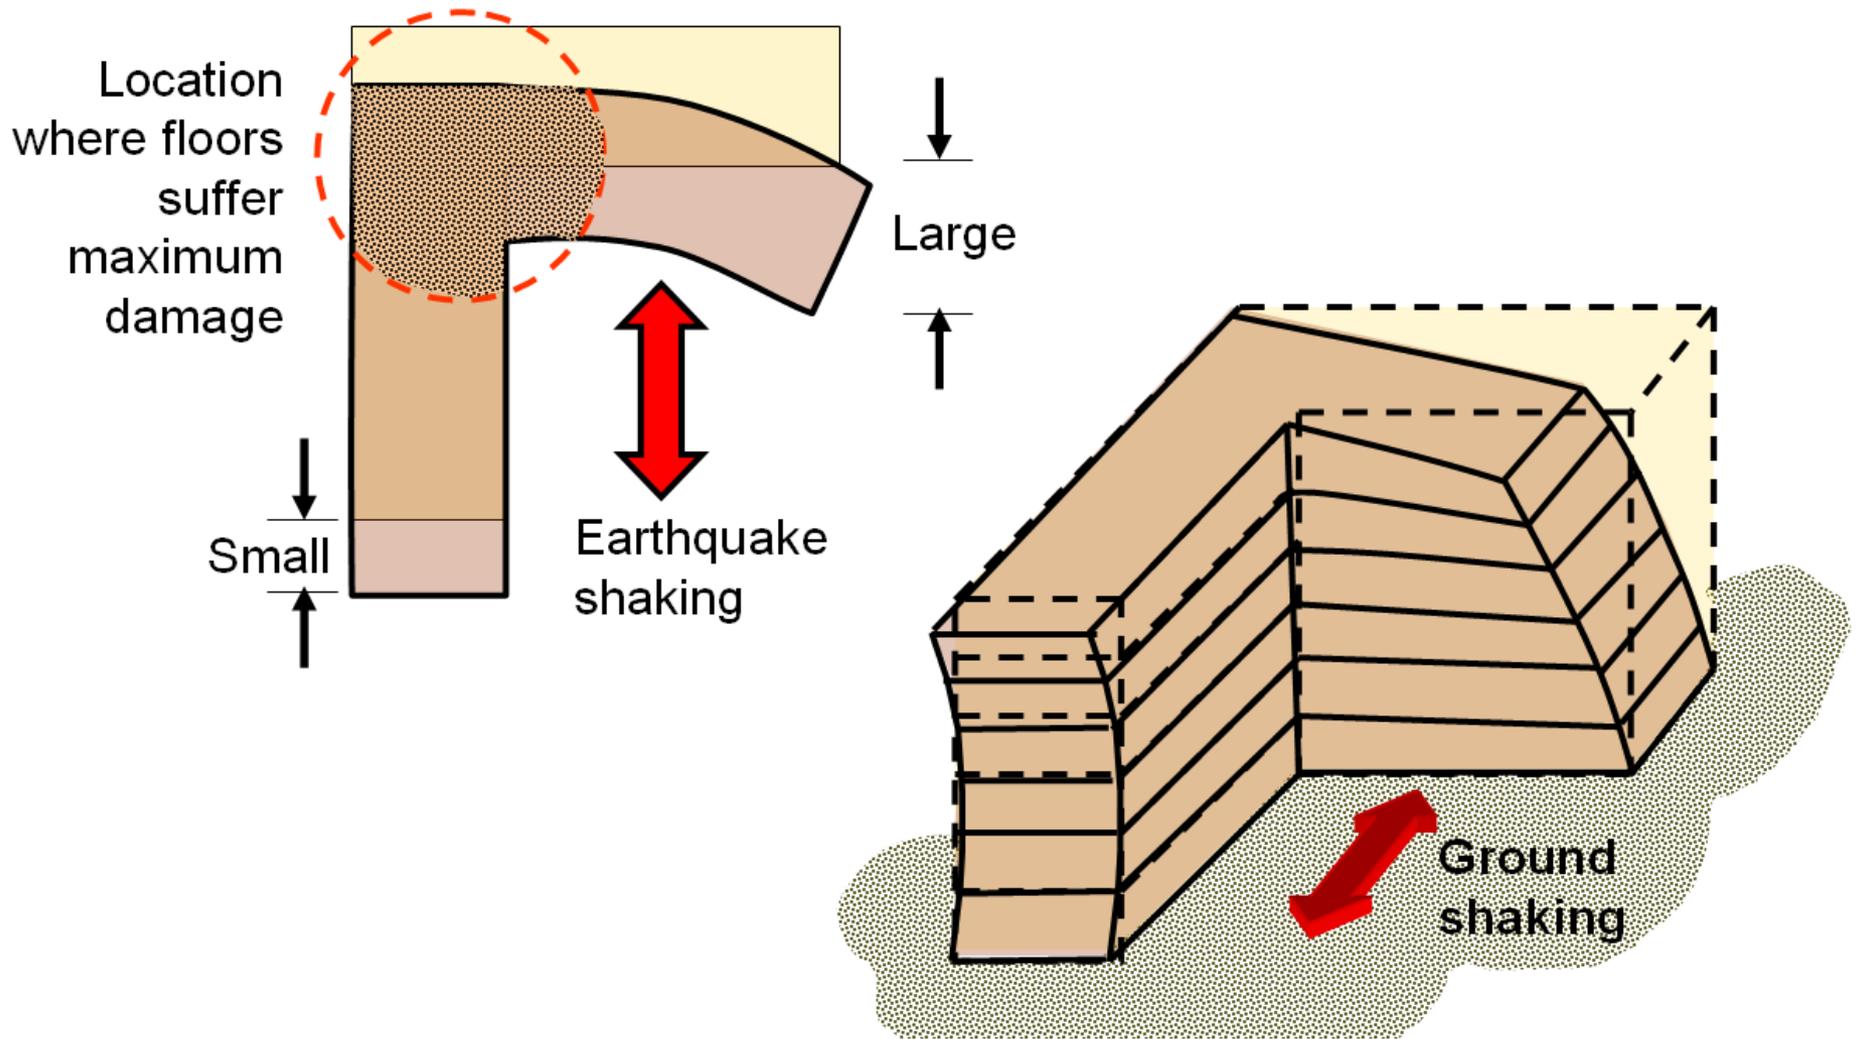
Tearing-off effect at the corner

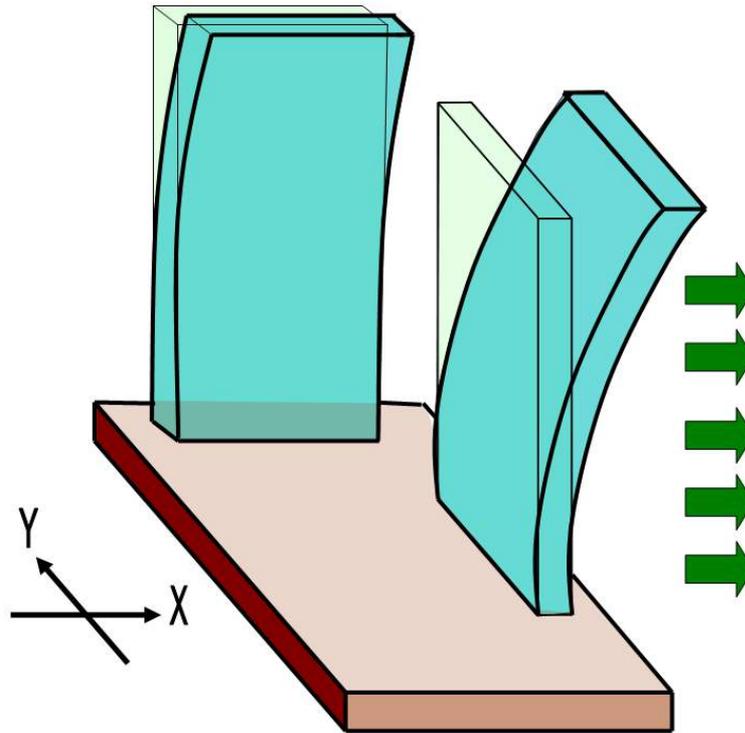
- Separation of segments
