# Structural Retrofit and Structural Risk Mitigation

Manish Kumar

*Training Workshop on Structural & Non-structural Risk Assessment of School Buildings*

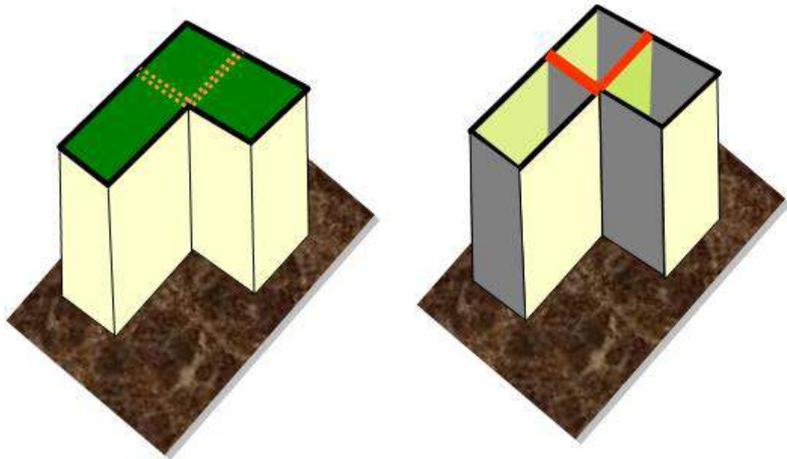
Collectors

Collector Walls

Tie the building together more strongly.

Place stiffening elements at the location

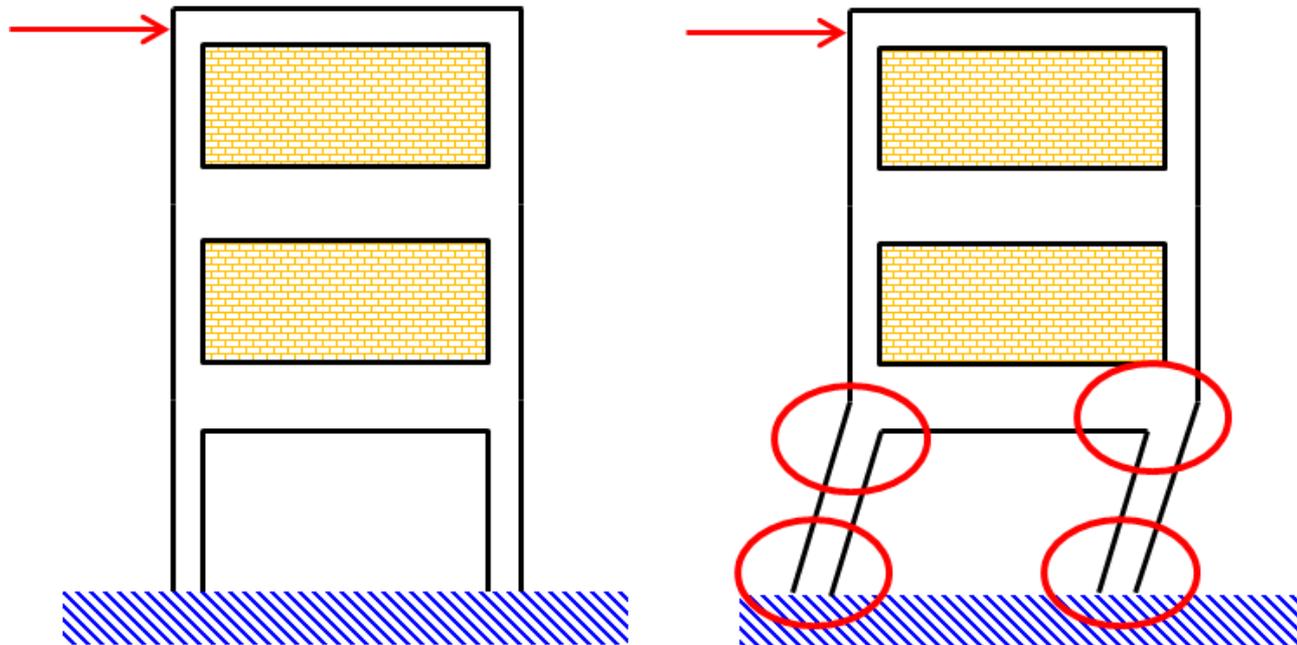
- Soft story
  - Parking lot, garage, shops

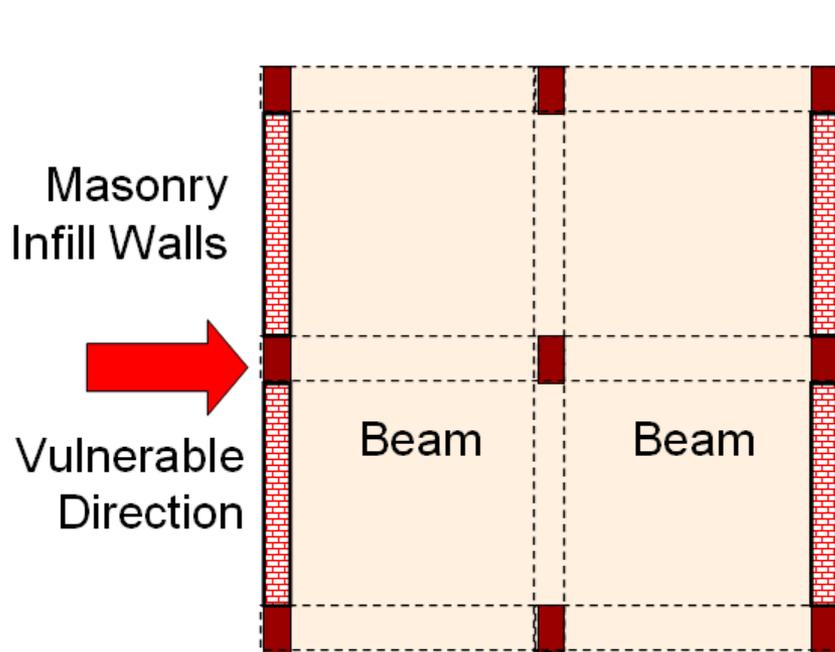
(a) Open Ground Storey

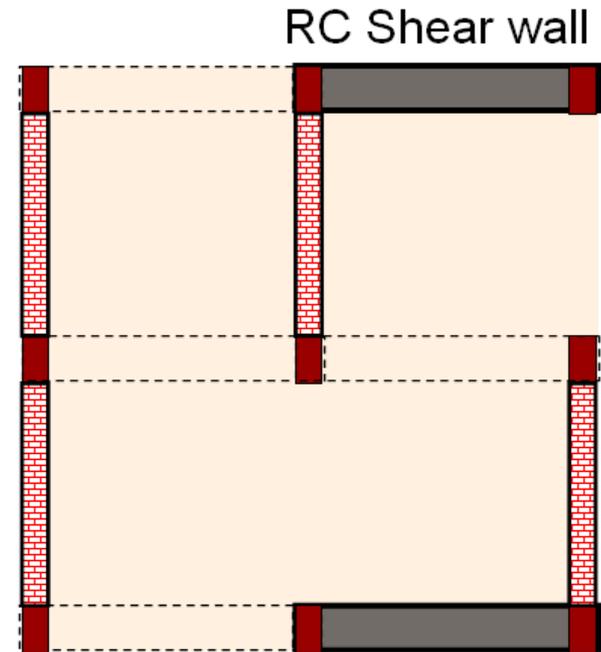
(b) Detrimental effects of Open Ground Storey avoided by using a RC shear walls

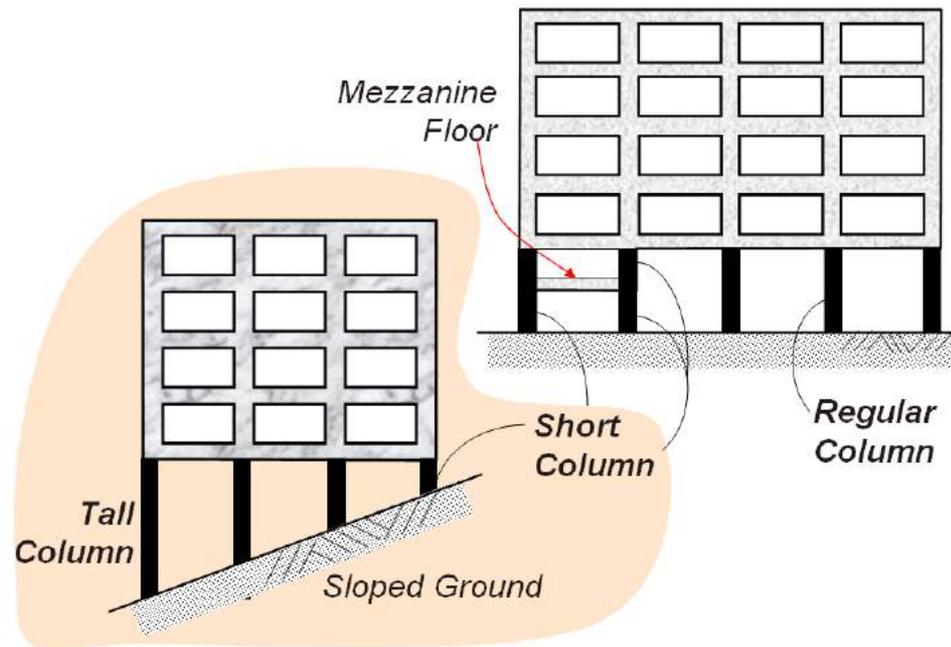
- Causes
  - Most deformation concentrated in a short length of the column

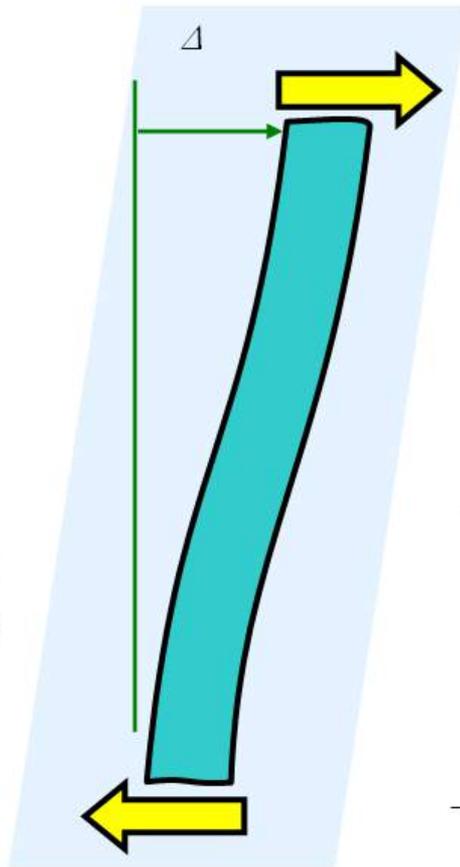
**Tall Column:**  
Attracts smaller  
horizontal force

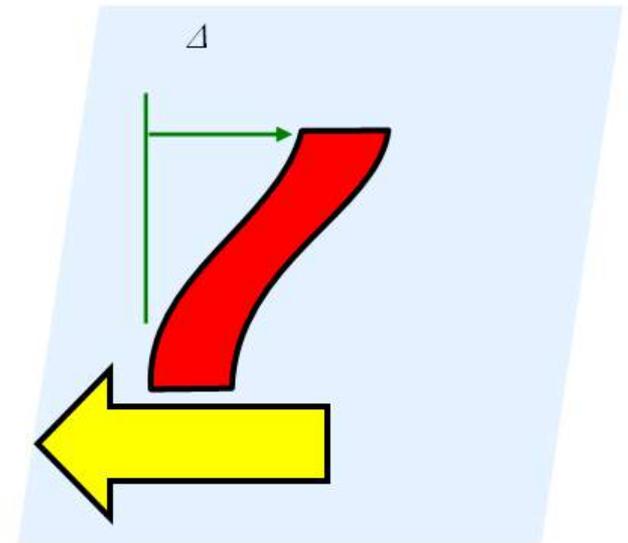
**Short Column:**  
Attracts larger  
horizontal force

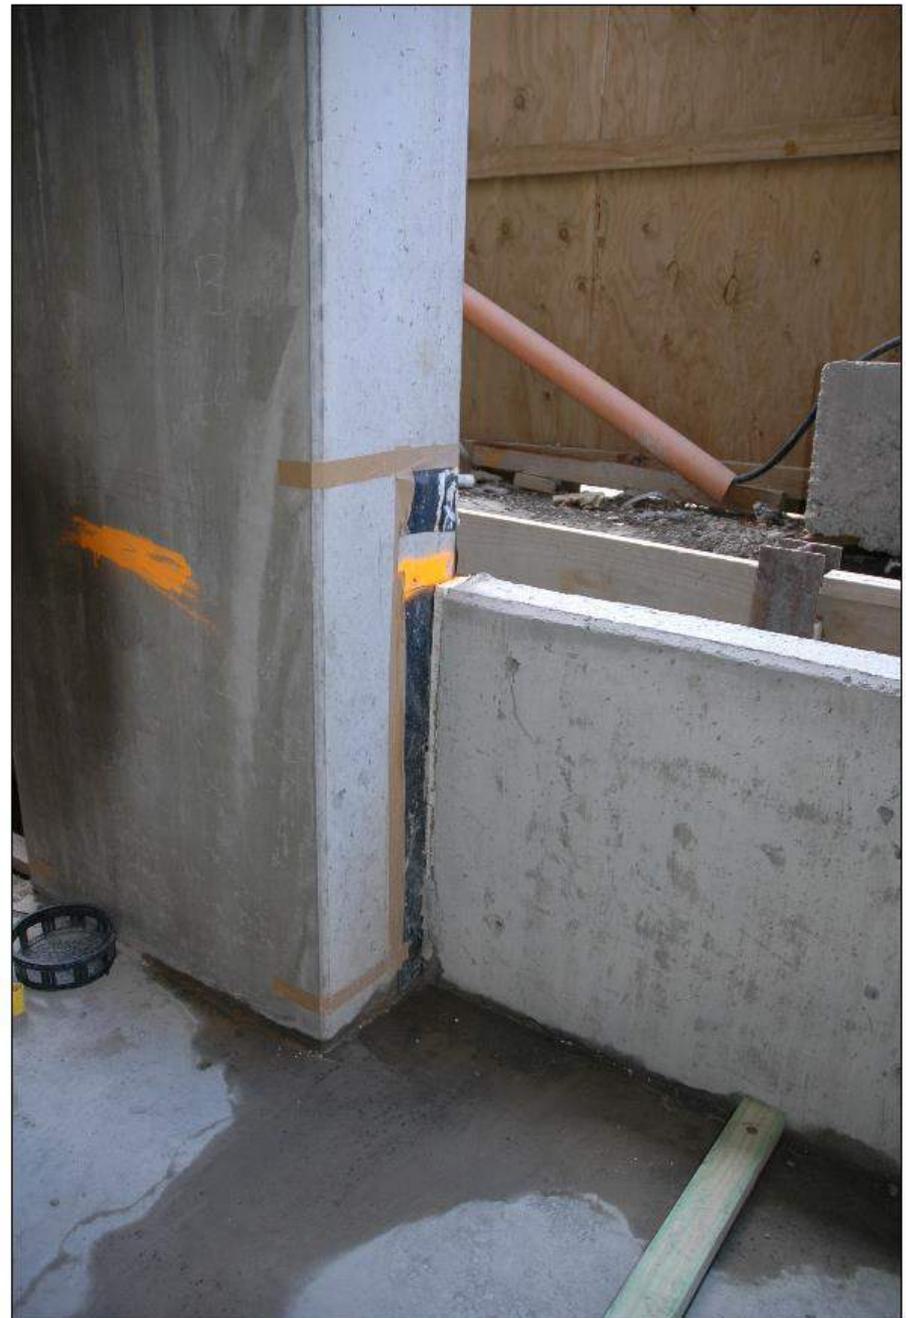
- Separation between column and wall

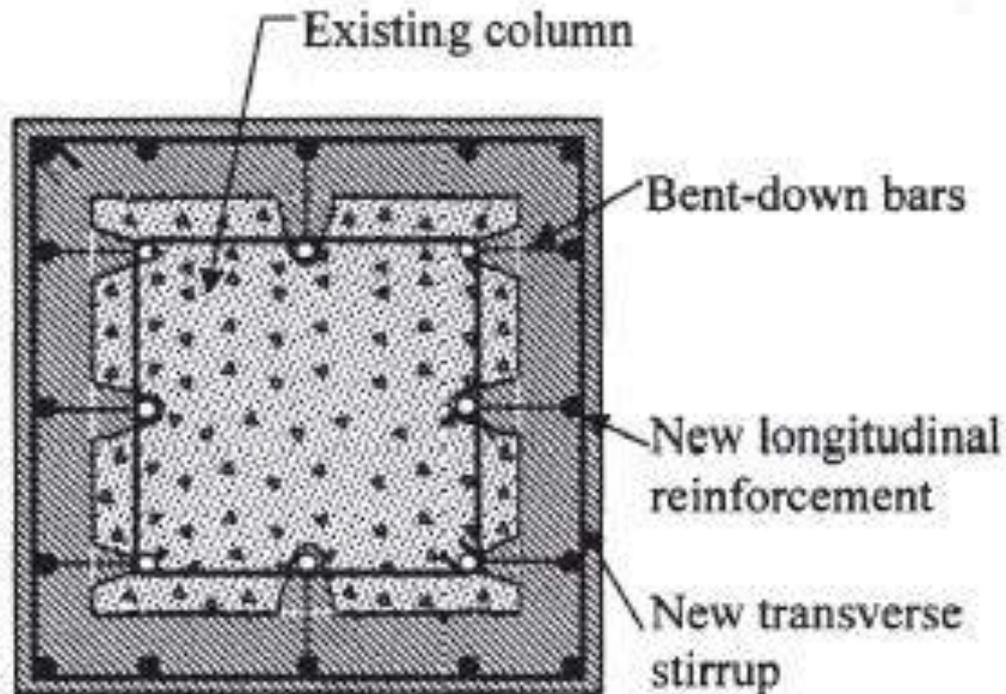
- Strengthening individual members
  - Jacketing

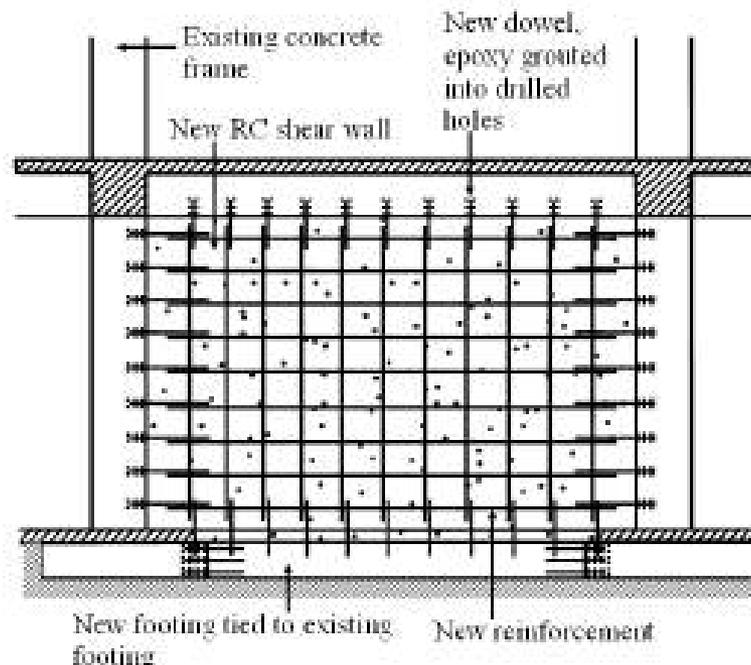
- Eliminating or reducing irregularity
  - Example: soft story can be mitigated through new shear walls

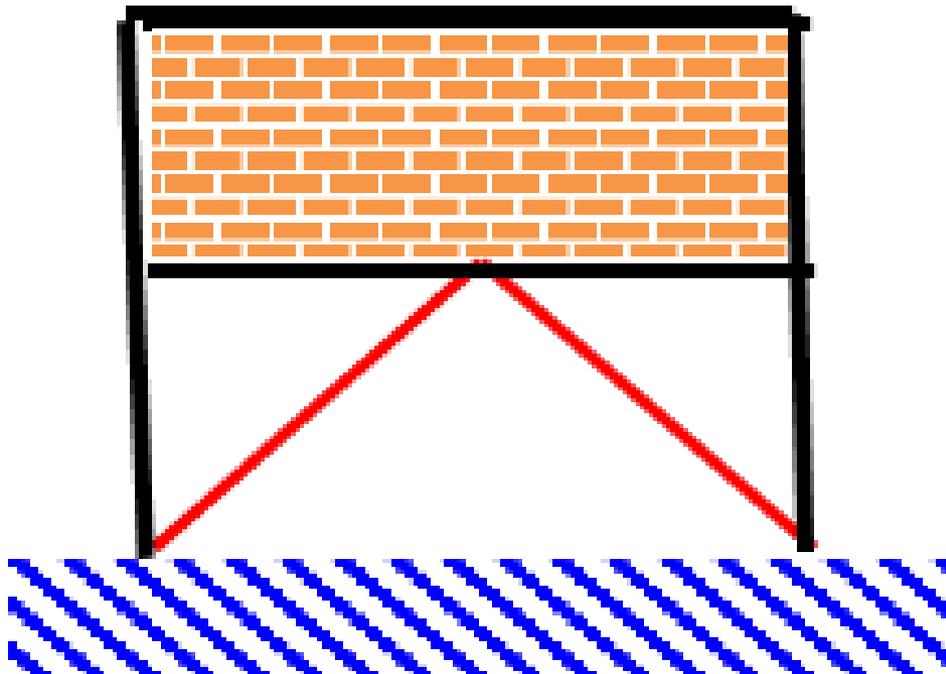
- Eliminating or reducing irregularity
  - Example: soft story mitigation through braces

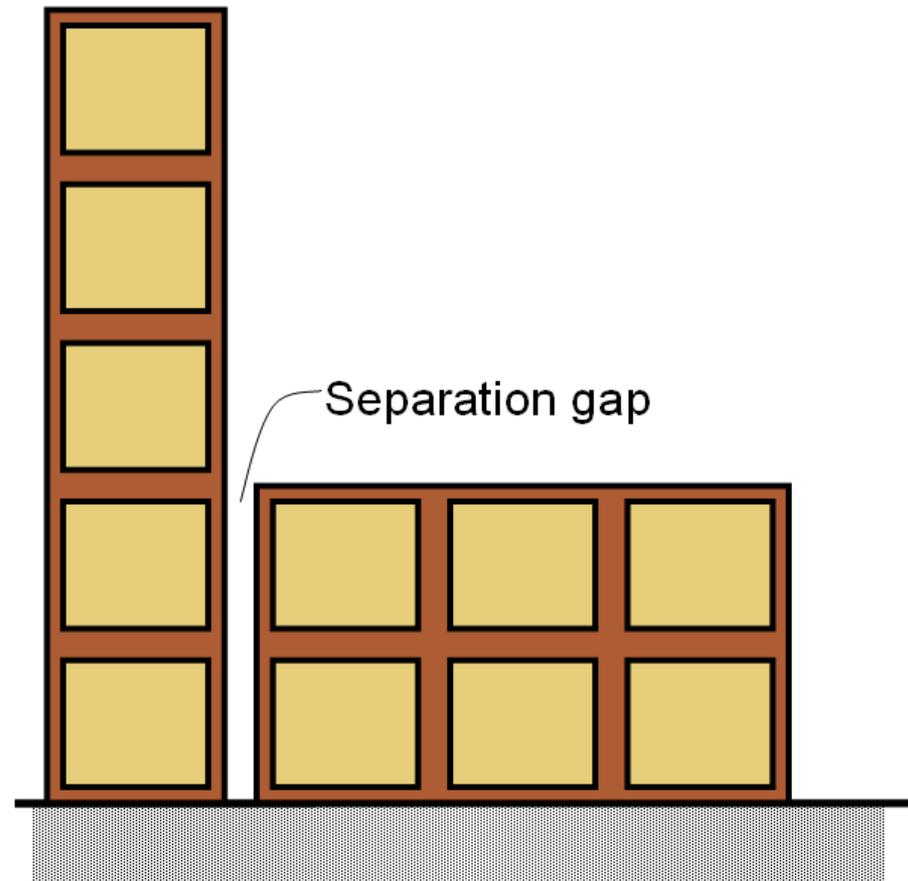
- Eliminating or reducing irregularity
  - Providing a seismic gap at the joints

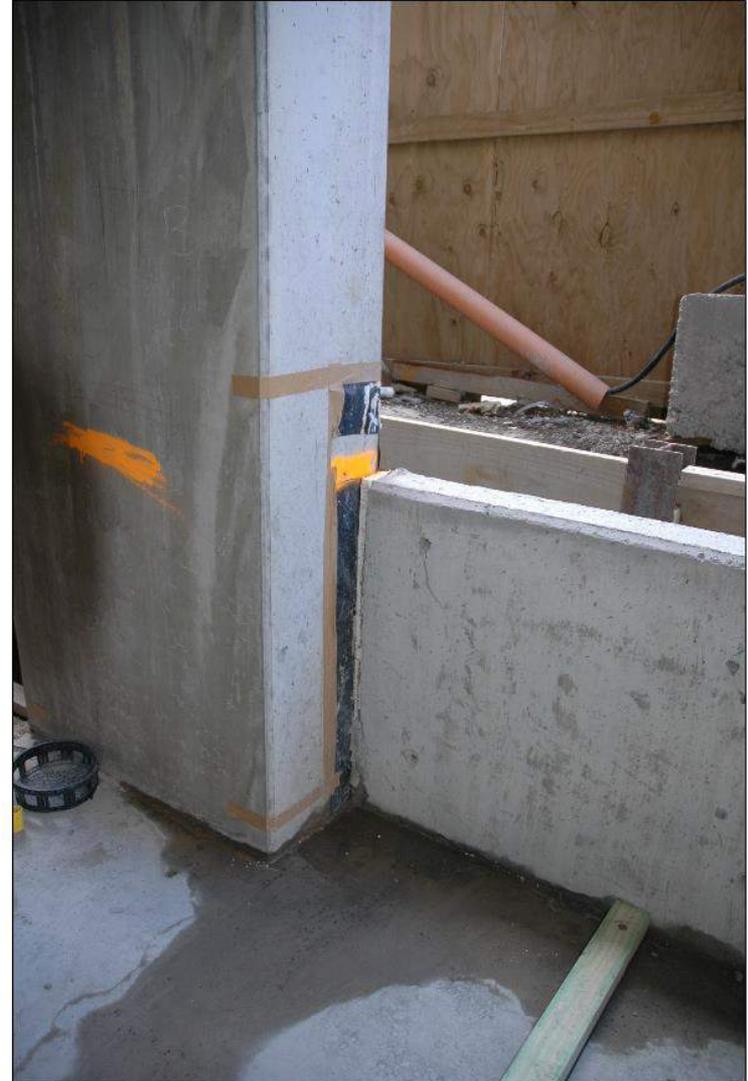
- Eliminating or reducing irregularity
  - Providing a gap to avoid short column effect

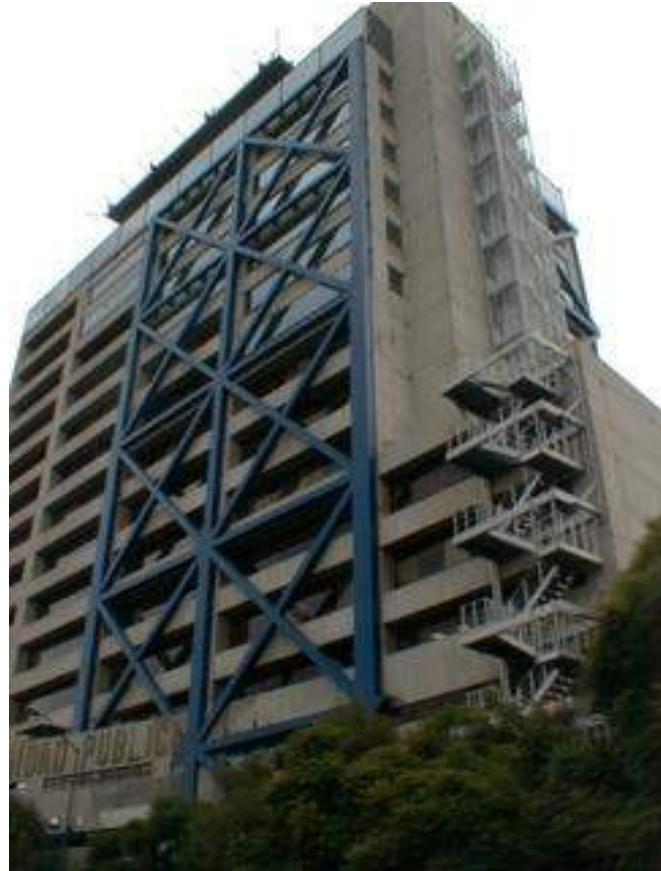
- Strengthening at structural level

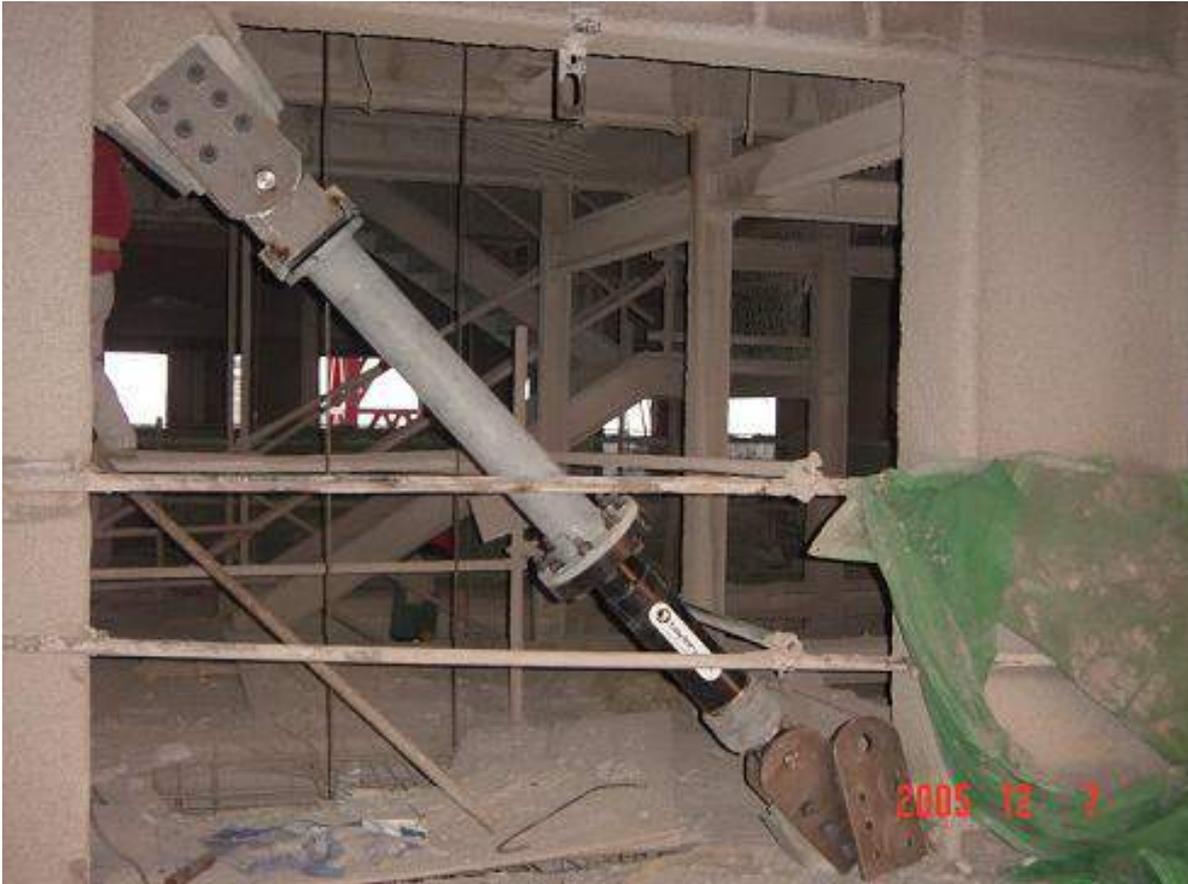
- Damping devices

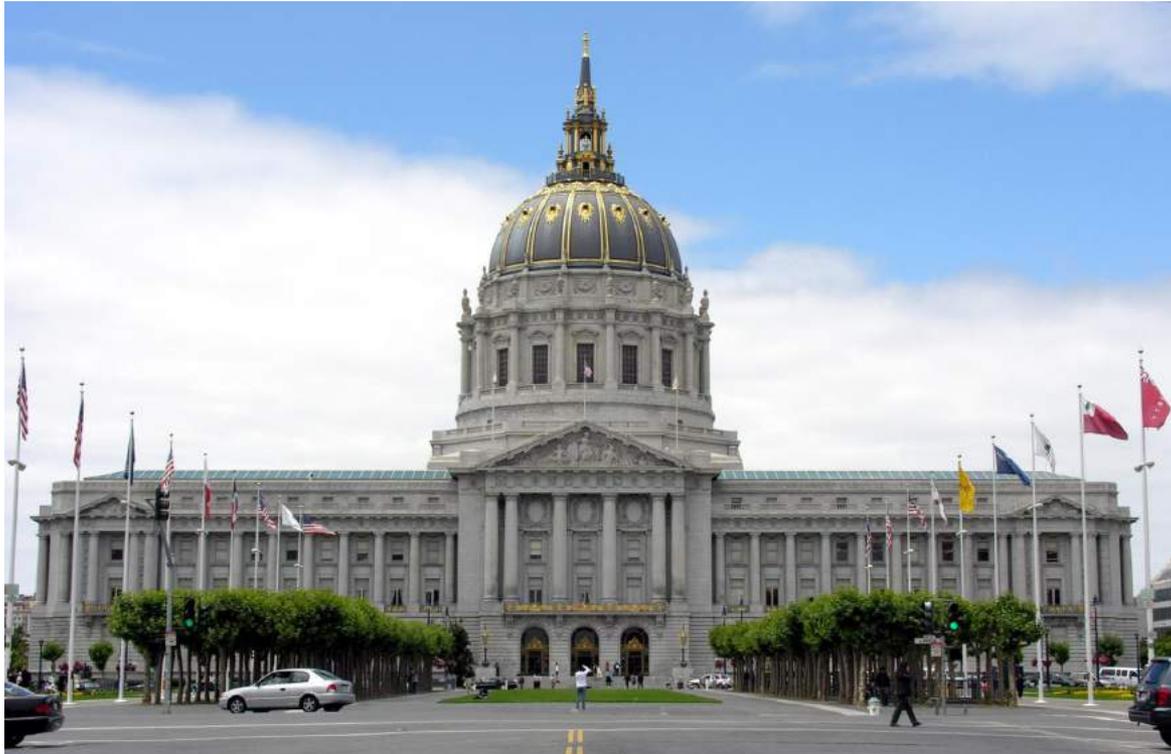
- Seismic isolation
  - San Francisco City Hall

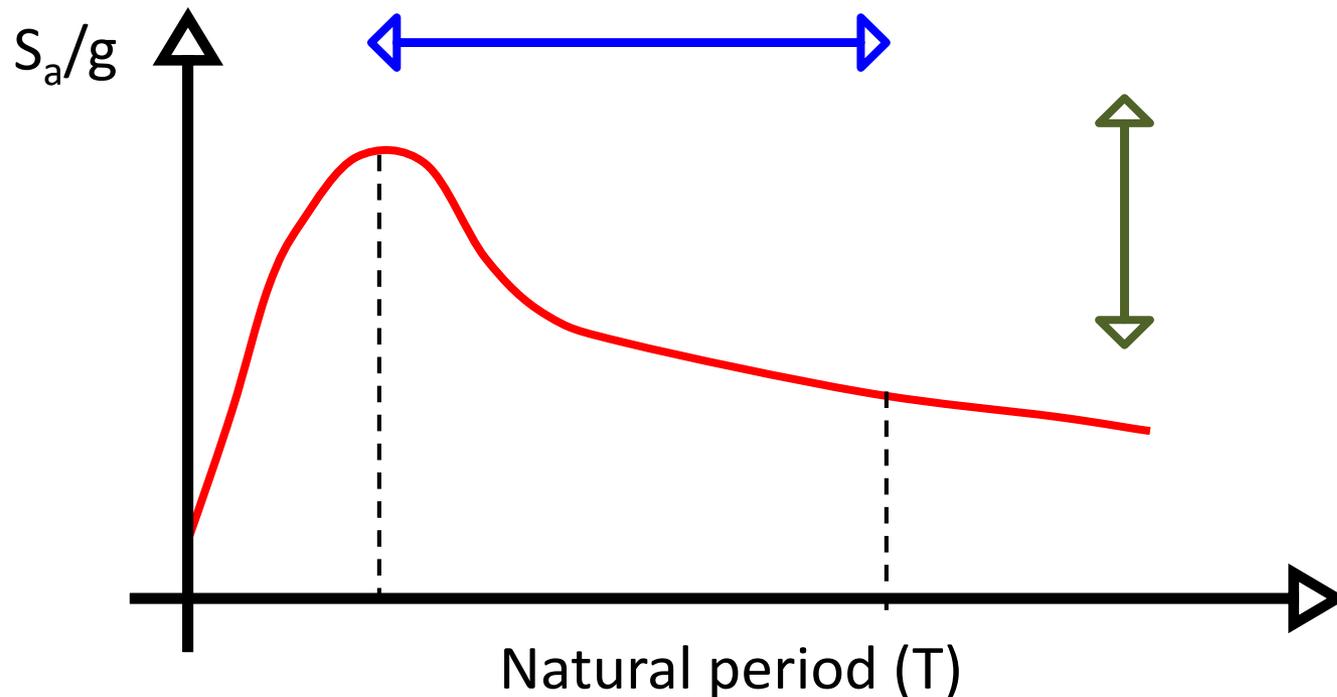
- Seismic isolation increases natural period, which reduces input energy

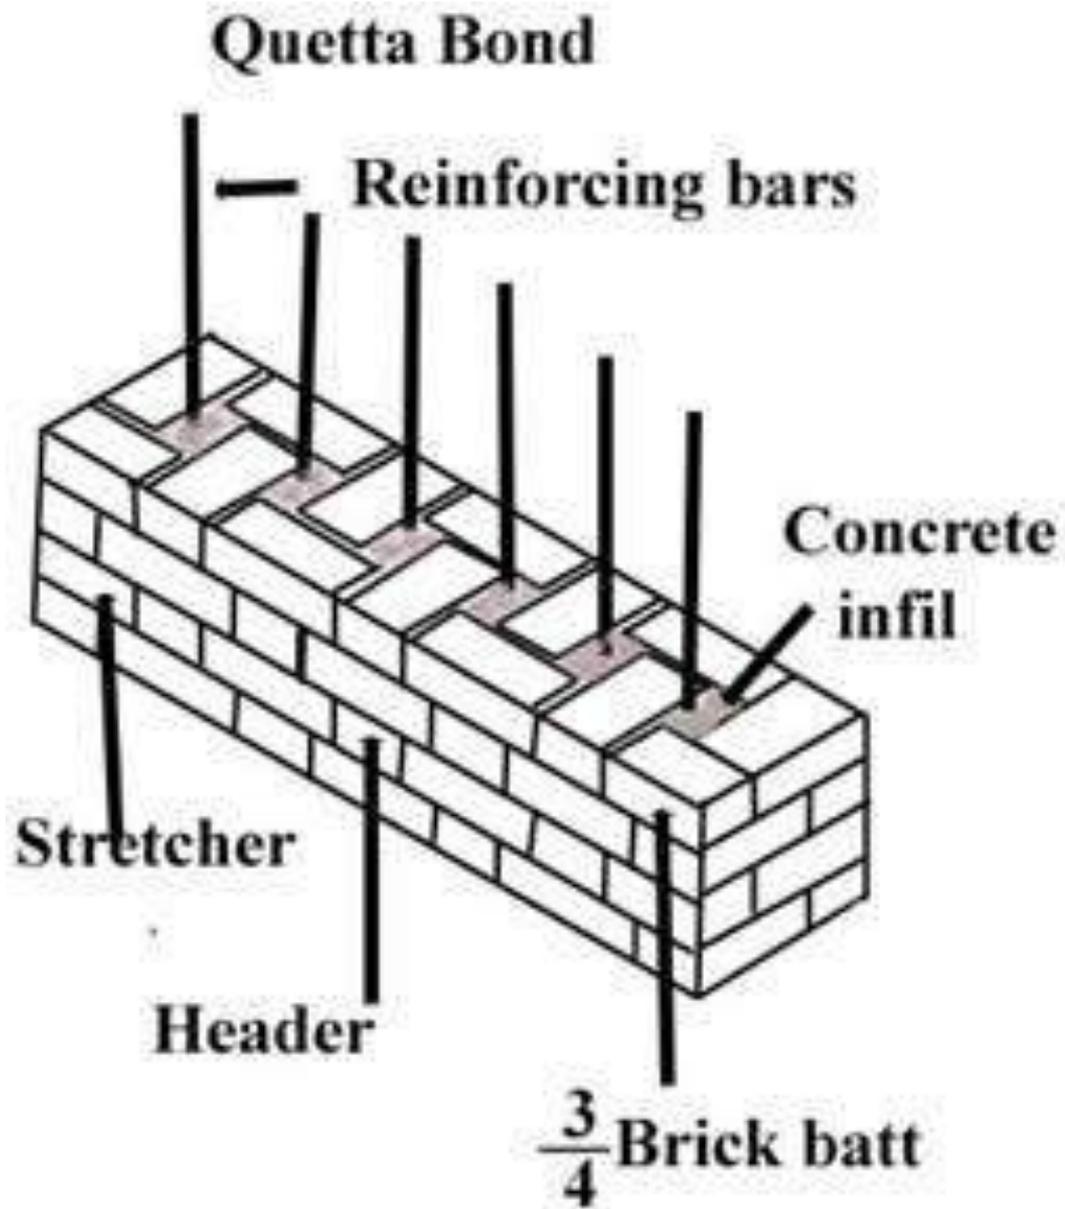
# Quetta bond

- 1931 Quetta earthquake, Baluchistan
  - Sardari Lal Kumar
    - Young engineer with Railways
    - Designed new earthquake-resistant staff quarters
    - Published a paper in 1933
      - First seismic zone map
      - Design coefficients
- 1935 Quetta earthquake
  - ~ 30,000 deaths
  - Houses designed by Kumar survived
