SEISMIC HAZARD ASSESMENT AND RAPID VISUAL SURVEY OF HOSPITAL BUILDINGS

Dr. S. T. G. Raghu Kanth

Dept. of Civil Engg.

IIT, Madras

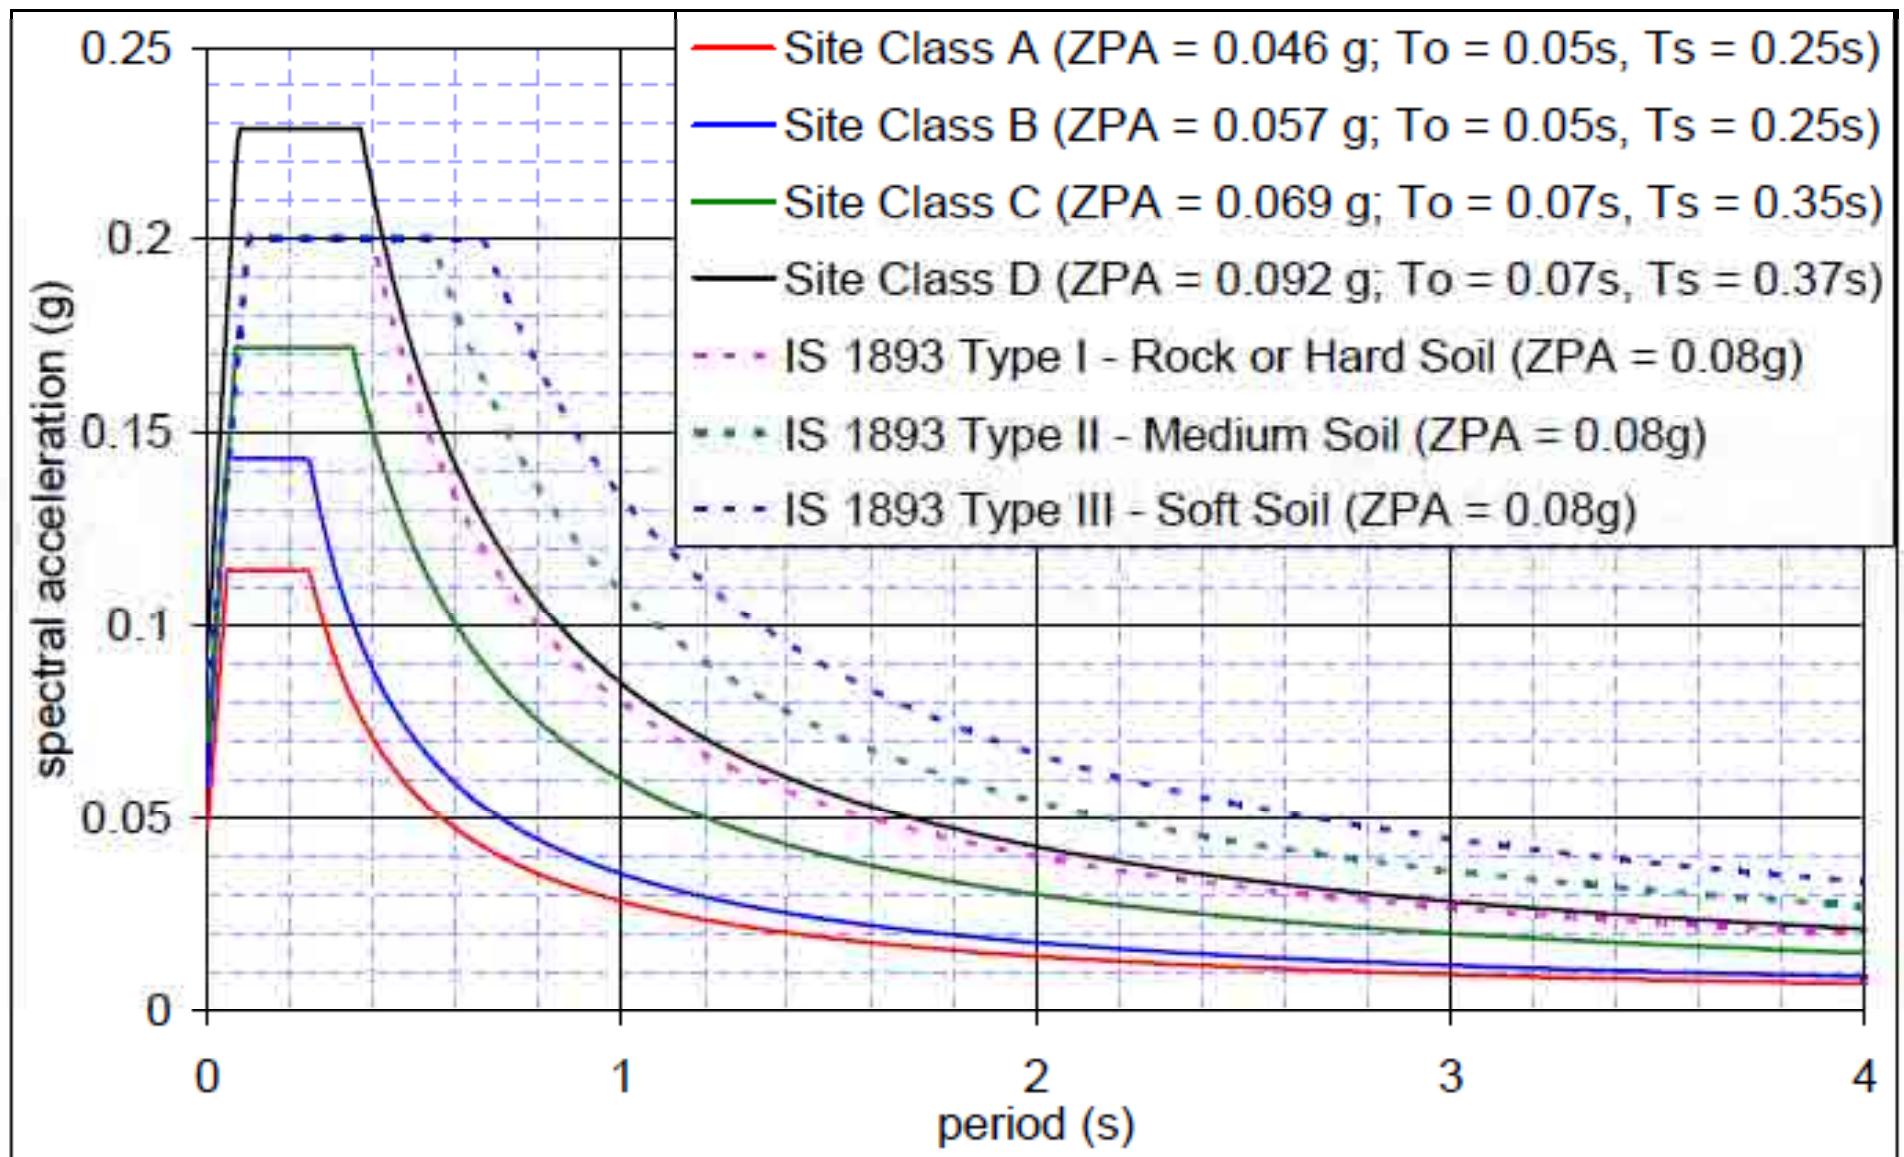
Comparison of IBC design spectra obtained using PSHA results with that specified in IS 1893:2002 for Mumbai

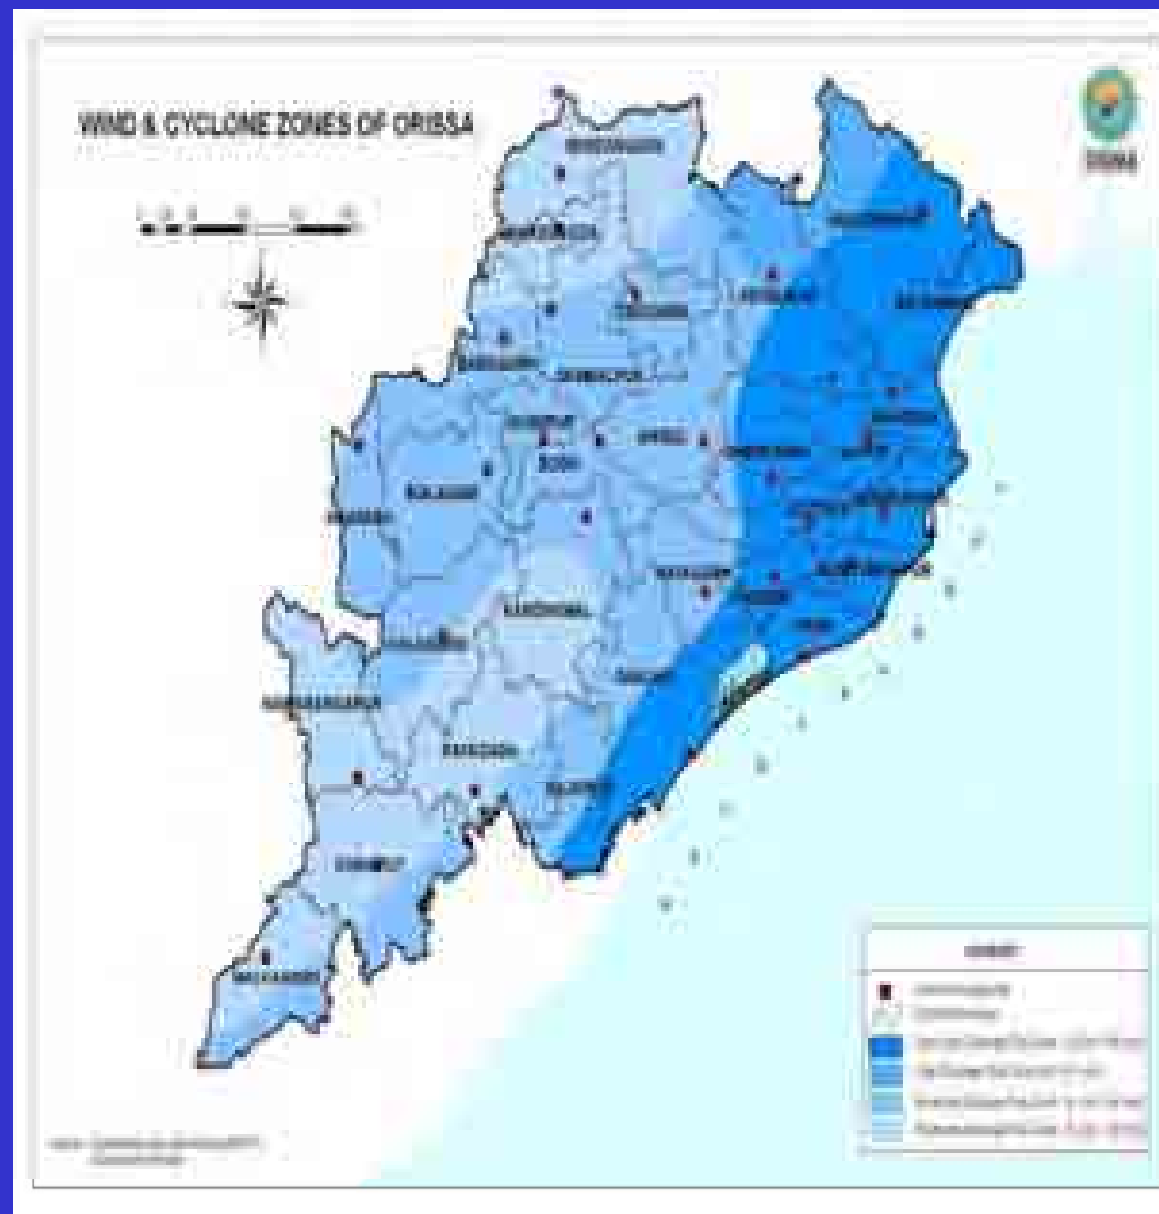
Wind and cyclone zones of Orissa
(Reference: OSDMA:
<http://www.osdma.org/>)
