Post Earthquake Rapid Damage Assessment Needs and Challenges

Shashank Mishra
Programme Manager (Disaster Risk Reduction)
Chief Technical Advisor (Myanmar Climate Change Alliance)
UN-Habitat, Myanmar

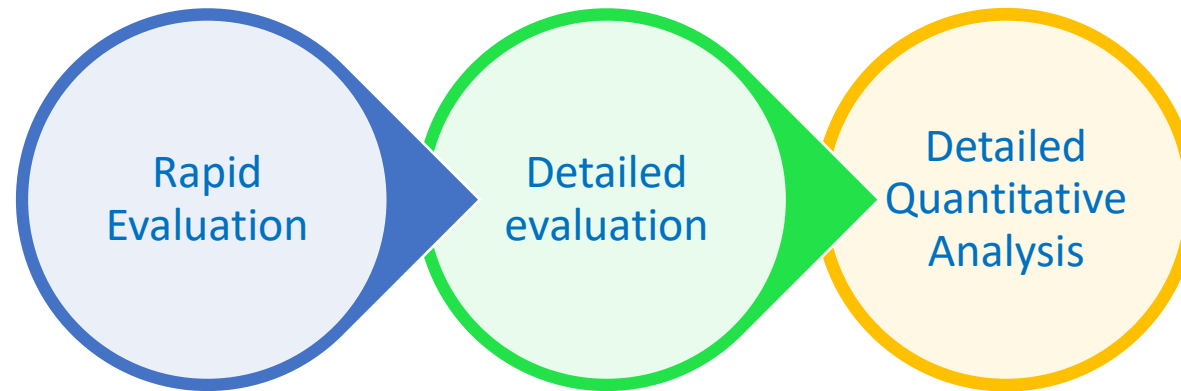
Most of the guideline adopted for conducting post earthquake damage assessment suggest a 3 step procedure

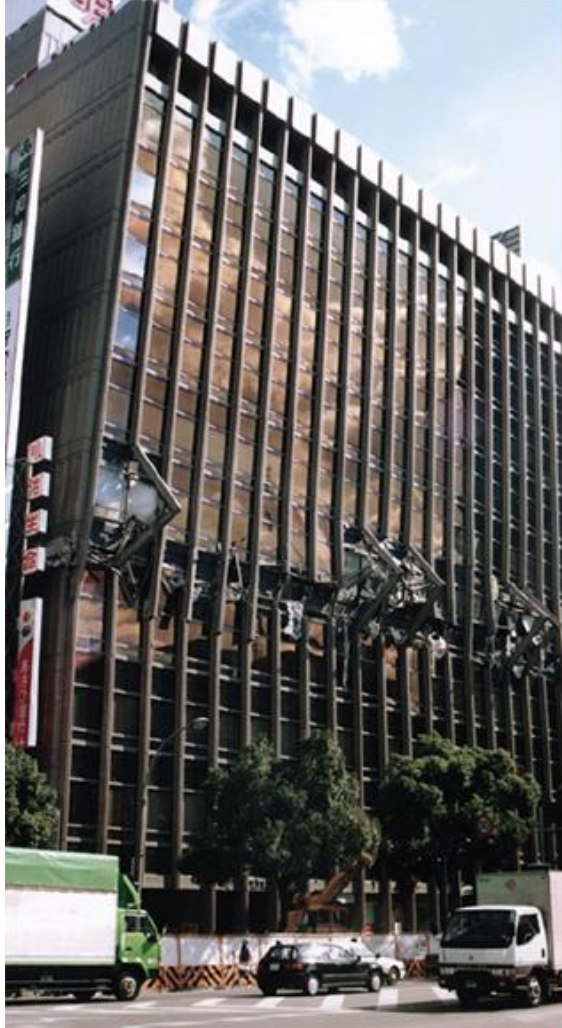
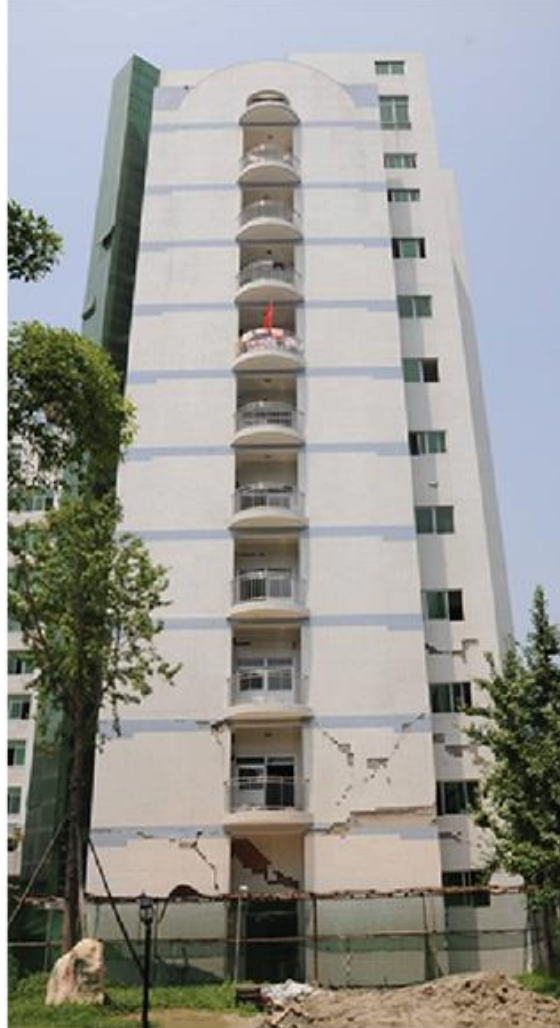
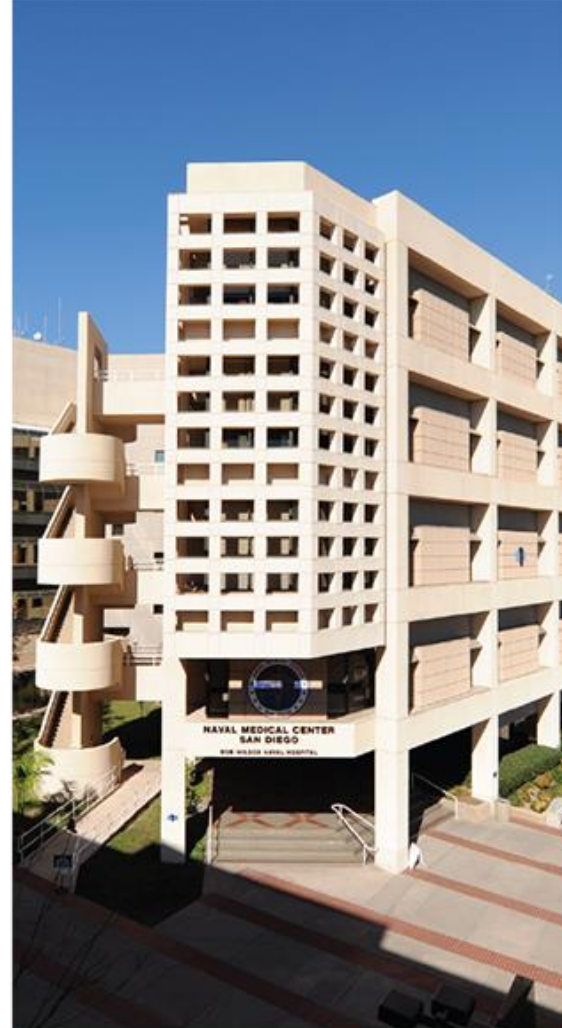
UNSAFE
DO NOT ENTER OR OCCUPY
(THIS PLACARD IS NOT A DEMOLITION ORDER)

This structure has been inspected, found to be seriously damaged and is unsafe to occupy, as described below:

Caution: This structure has been inspected and found to be damaged as described below:

This structure has been inspected (as indicated below) and no apparent structural hazard has been found.

for evaluating earthquake-damaged buildings and posting them as INSPECTED (apparently safe, green placard), LIMITED ENTRY (yellow placard), or UNSAFE (red placard).

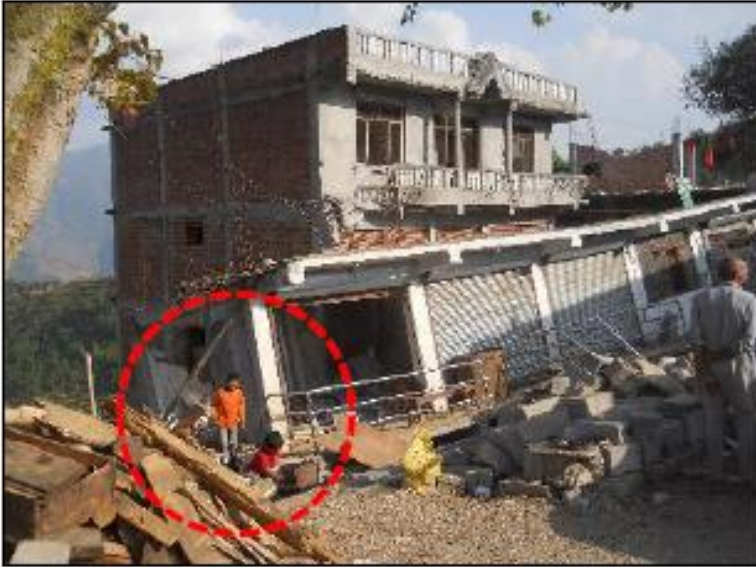
No Barricading : Children playing near the damaged building

- **Wrong interpretation of words** : No absolute safe building as there is always a level of risk involved i.e. safe but be cautious (Canterbury earthquake also had same issue)
- **People even occupied** or worked around building with red placard
- Barricading of severely damaged or collapsed building **was not followed a norm**: In a subsequent earthquake , it can be very dangerous
- In some areas, people were forced to occupy the damaged buildings as there was **no alternative options**
- This situation was even complicated due to lack of **security arrangements of personal property**
- Many people erected tents near their damaged houses to safeguard their property despite the risk of nearby damaged buildings
- **Perception of risk** was a major issues for people from different cultural, educational, socio-economic background

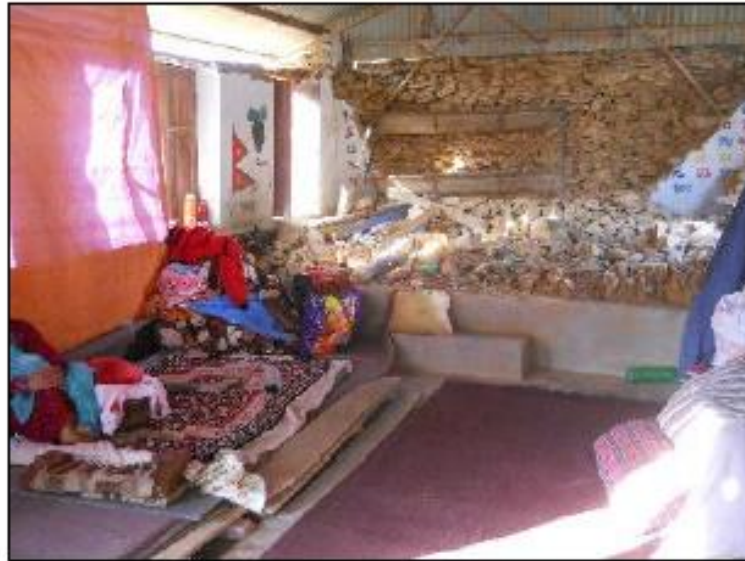
School building with collapsed walls. The building was used for post-earthquake accommodation.

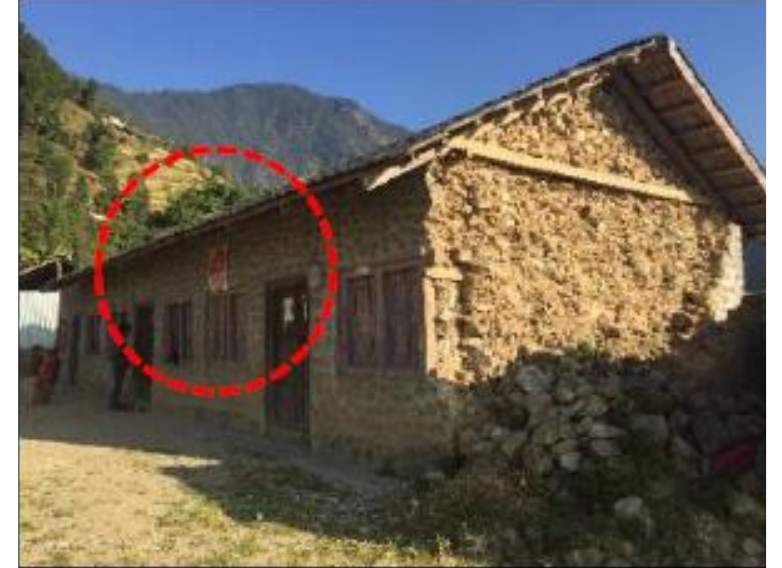
Occupied school building placarded as “unsafe”
