Case Study 3: Sundarbans, India

Anurag Danda | WWF-India

Critical Water Infrastructure in the Sundarbans

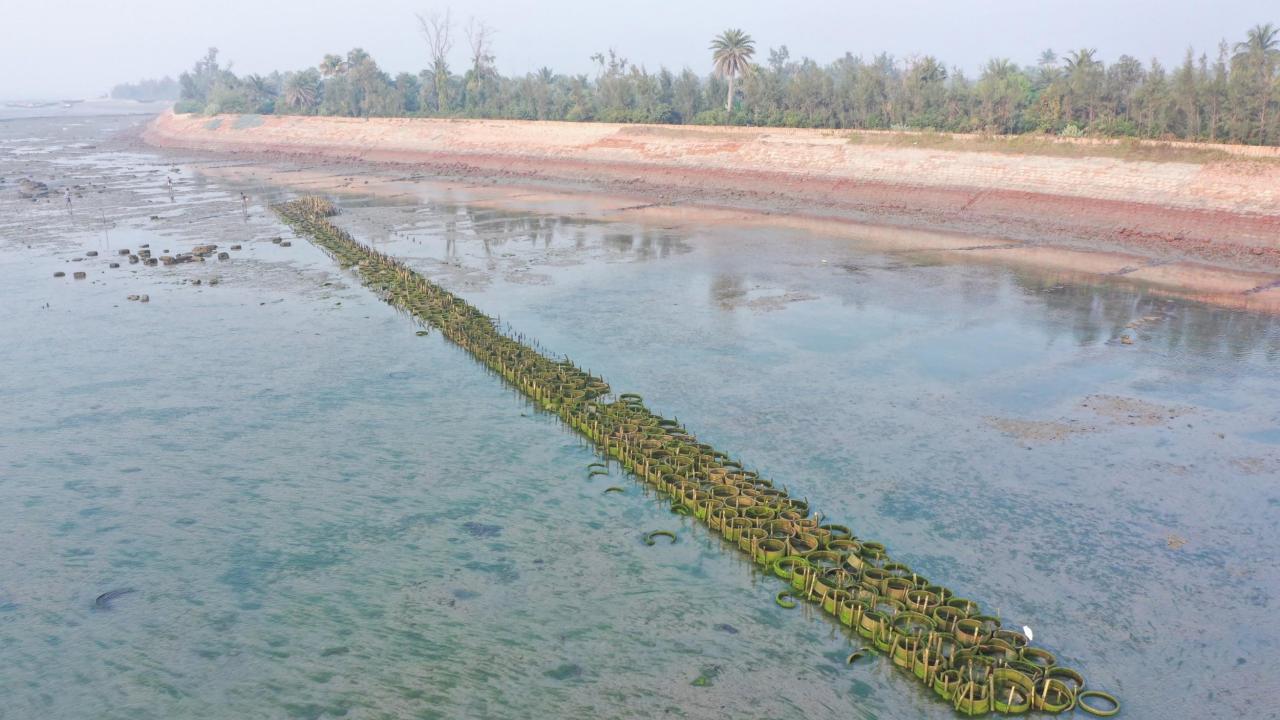
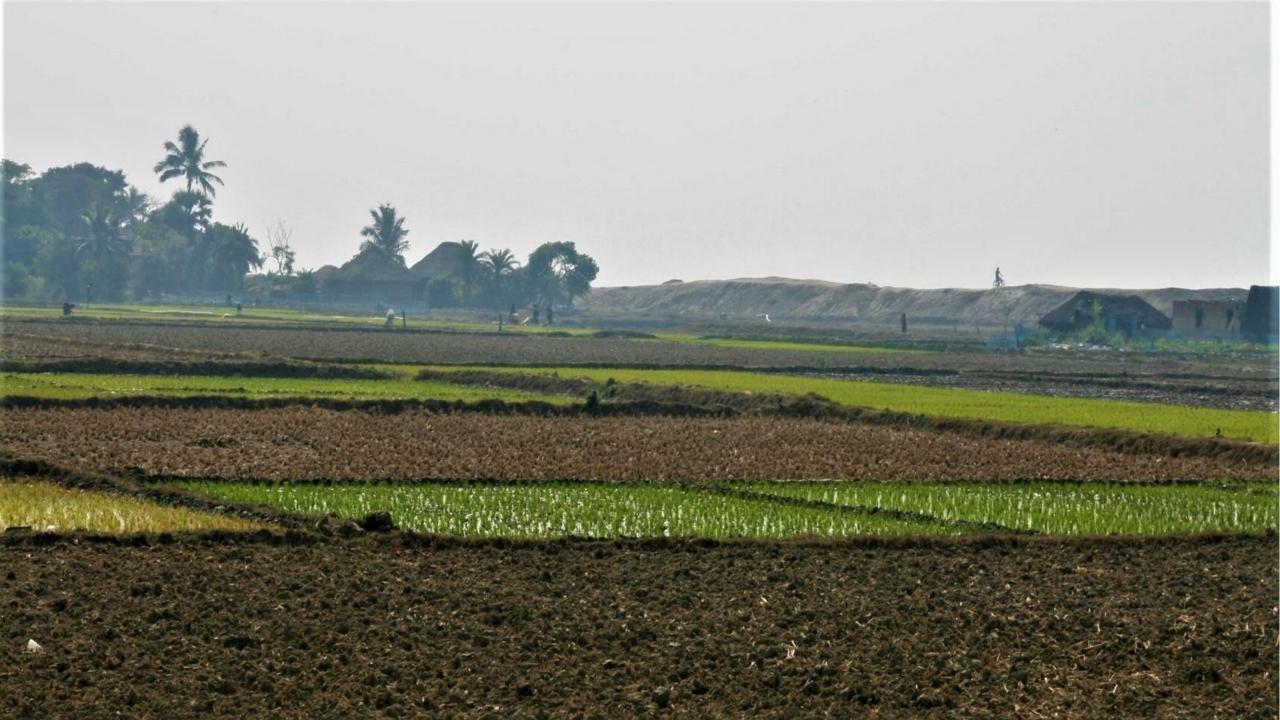
Embankments: 35 inhabited islands, 1800 km, erected late 18th century onwards

Freshwater ponds: Common/Public property & private property

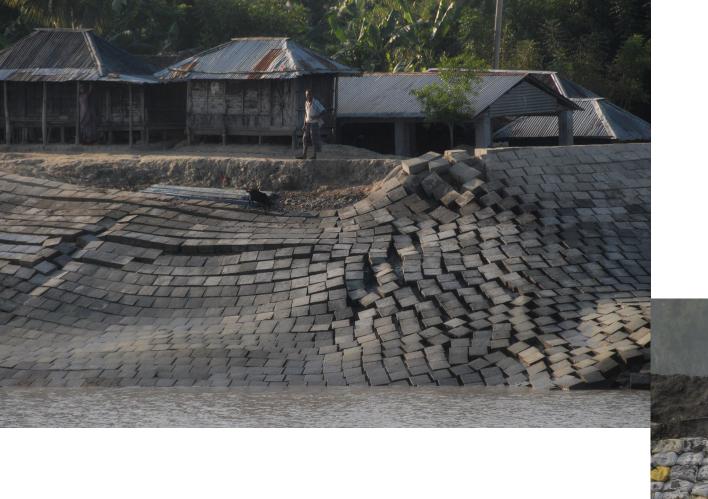
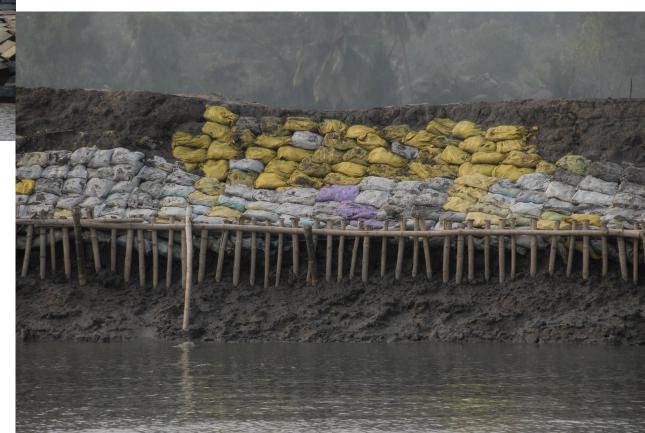
Embankments: toe-line erosion and vertical collapse due to tidal action and breach due to overtopping during storm surge

• Freshwater ponds: inundation during storm surge
